SERIOUS INCIDENT

Aircraft Type and Registration:	Airbus A319-131, G-EUPM
No & Type of Engines:	2 International Aero Engine V2522-A5 turbofan engines
Year of Manufacture:	2000 (Serial no: 1258)
Date & Time (UTC):	19 October 2016 at 0759 hrs
Location:	Manchester Airport
Type of Flight:	Commercial Air Transport (Passenger)
Persons on Board:	Crew - 7 Passengers - 117
Injuries:	Crew - None Passengers - None
Nature of Damage:	Damage to nose landing gear barrel, axle, torque links, steering actuator cylinder and wiring harnesses
Commander's Licence:	Airline Transport Pilot's Licence
Commander's Age:	46 years
Commander's Flying Experience:	11,900 hours (of which 10,700 were on type) Last 90 days - 169 hours Last 28 days - 62 hours
Information Source:	AAIB Field Investigation

Synopsis

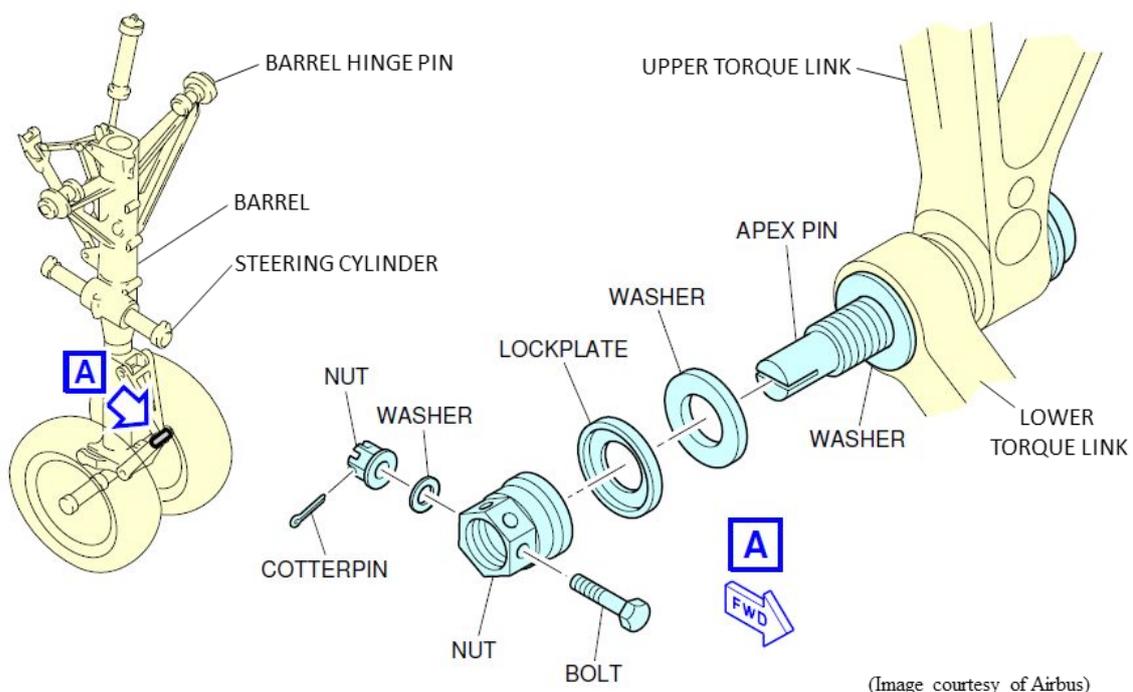
Figure 4

Nosewheel steering is performed by a hydraulic actuating cylinder attached to the landing gear barrel. The hydraulic actuator rotates the upper torque link, which transmits torque through the lower torque link to rotate the nose wheels. The upper and lower torque links are attached by an apex pin (Figure 4), providing articulation of the torque links to accommodate vertical displacement of the oleo strut.

Nose landing gear torque link apex pin assembly

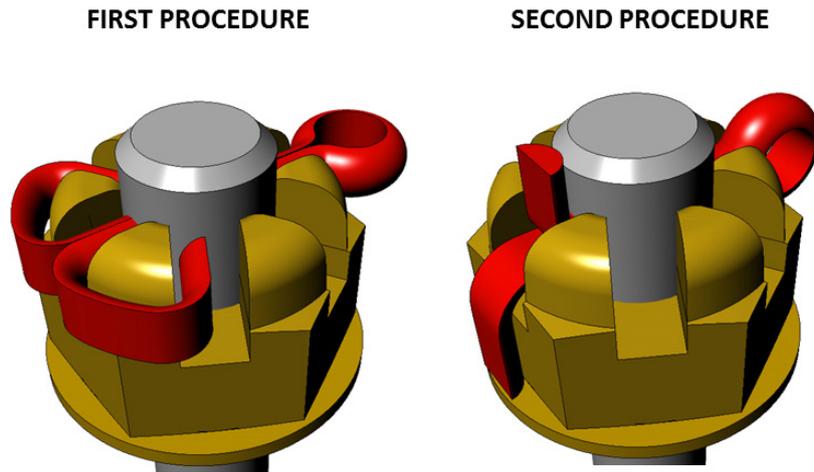
Figure 5

The AMM requires that the locking bolt passing through the apex pin nut is assembled with a washer and a castellated nut, and that the castellated nut is secured by the insertion of a steel cotter pin. The AMM permits two methods of cotter pin installation for this assembly (Figure 5); a '*First Procedure*' in which the cotter pin is installed perpendicular to the bolt axis, and the projecting prongs of the cotter pin are bent around the sides of the castellated nut and, optionally, are bent inwards into the castellated nut slots. Alternatively a '*Second Procedure*' may be used, where the cotter pin is installed parallel with the bolt axis and the projecting upper prong of the cotter pin is bent tightly against the shank of the bolt, and the lower prong is bent tightly against the base of the nut.

Approved methods of cotter pin installation for apex nut lock bolt

The sealant witness marks showed that the locking bolt had been assembled with a cotter pin prior to the application of the sealant, with the cotter pin oriented parallel to the locking bolt as per the AMM 'Second Procedure'. The head of the cotter pin had been pointing outboard as shown in the diagram in Figure 7. There was an area of missing sealant in the vicinity of the outboard edge of the castellated nut. The edges of this area of missing sealant were of a torn appearance, consistent with this area having detached from the main mass of sealant at some point after the sealant had been applied and cured.
