ACCIDENT

Aircraft Type and Registration:	Dassault Falcon 7X, VQ-BSO	
No & Type of Engines:	3 Pratt & Whitney Canada PW307A engines	
Year of Manufacture:	2009 (Serial no: 64)	
Date & Time (UTC):	24 November 2016 at 1450 hrs	
Location:	London City Airport	
Type of Flight:	Commercial Air Transport (Passenger)	
Persons on Board:	Crew - 3	Passengers - 1
Injuries:	Crew - None	Passengers - None
Nature of Damage:	Minor abrasions to the right winglet	
Commander's Licence:	Airline Transport Pilot's Licence	
Commander's Age:	43 years	
Commander's Flying Experience:	7,900 hours (of which 2,687 were on type) Last 90 days - 65 hours Last 28 days - 37 hours	
Information Source:	Aircraft Accident Report Form submitted by the pilot

Synopsis

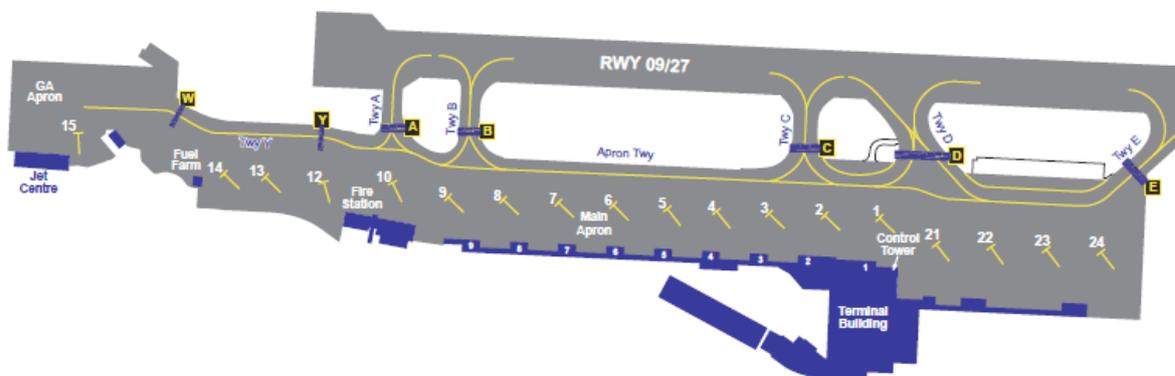
Figure 1

London City Airport Parking/Docking Chart

The aircraft had arrived from Rotterdam on a private flight. The weather was good and the airport's apron surface was dry. The intention of the ground handling staff was to park the aircraft on the General Aviation (GA) apron, located at the western end of the airport (Figure 1), 'nose in' to the 'Jet Centre' terminal building.
