**Occurrence - Investigation Report**  
**Right Main Landing Gear Damaged at Landing**  
**Jordan Aviation**  
**Boeing 737-400 JY-JAQ**  
**Kabul International Airport**  
**Kabul, Afghanistan**  
**SFW 502**  
**OAHR-OAKB**  
**10 December 2016**

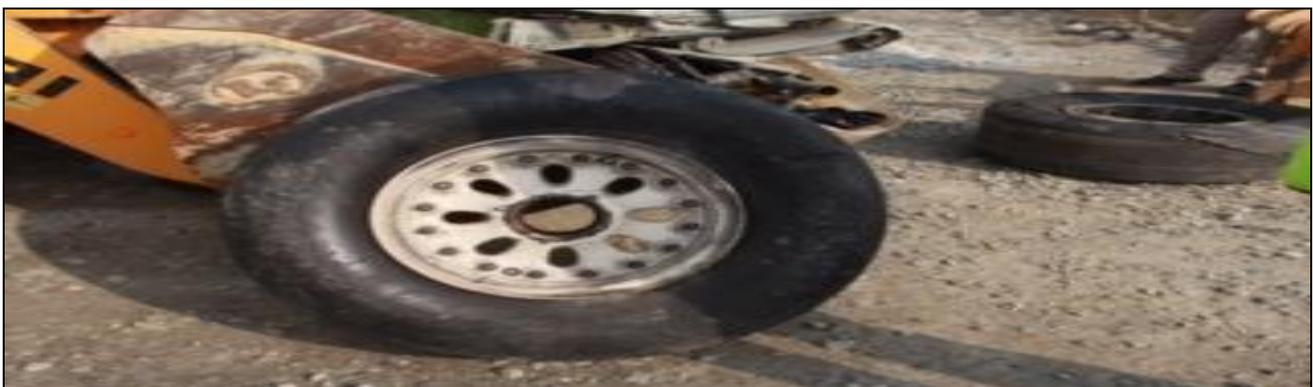
The tyres suffered damage no several locations, the tires were showing damage on the side walls.

The aircraft's right-hand main landing gear inboard tire shaking tire marks occurred for a distance of approximately 400 - 500 m, at this time the right main landing gear had detached and was dragged away, causing the right wing to drop. There was evidence of runway surface damage at almost similar intervals of appearing together with the hard tire contact marks, and this may also indicate that both tires were damaged after the shimmy damper failed and the oscillations were occurring.

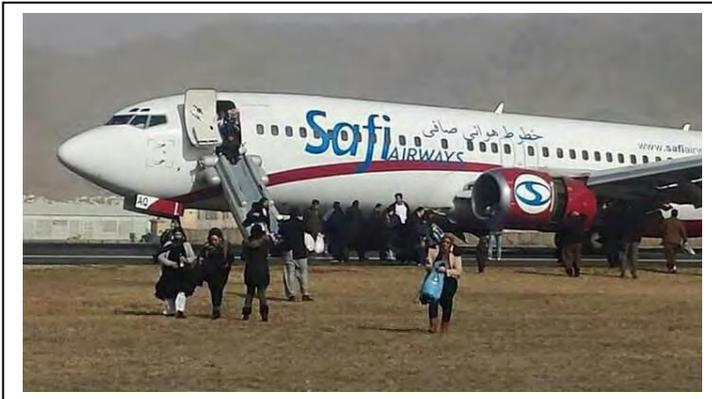
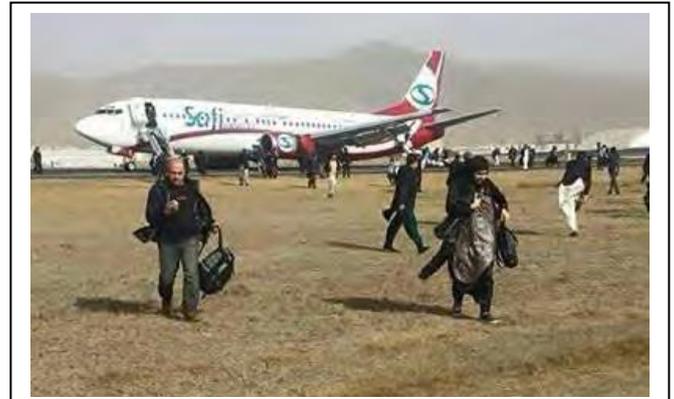
An evacuation of the passengers was carried out after the instruction of the PIC to evacuate the Aircraft through the L1 and L2 exits, Cabin crew managed to evacuate all the passengers without any injuries in less the one minute.

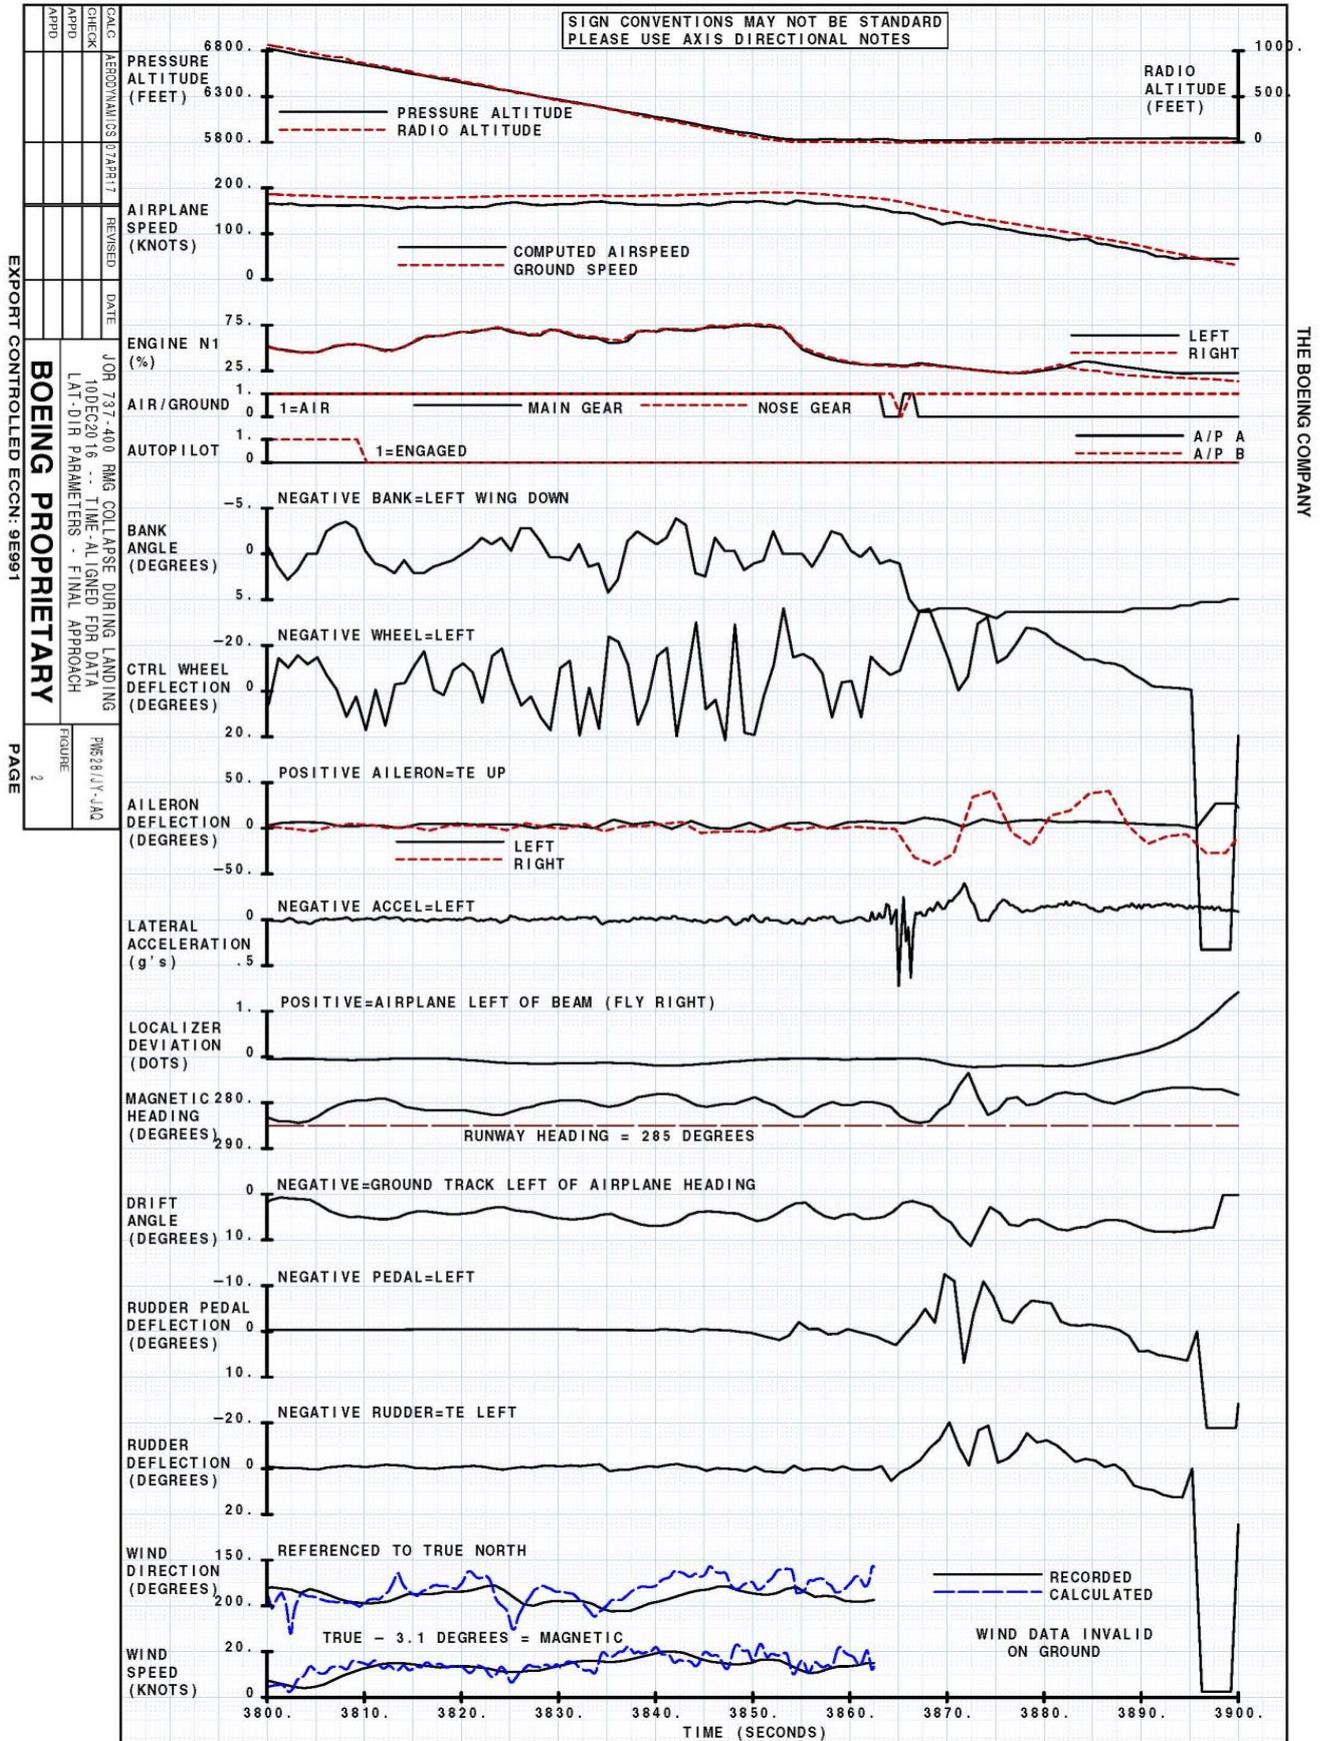
FDR Analysis - Figure 2

The FDR data show the airplane descending from 1000 feet radio altitude (RA) configured for flaps 30 landing with the speedbrakes armed, the autopilot disengaged by time 3810 seconds, and the autothrottle engaged through touchdown (Figure 1). The airplane was on approach to Runway 29 at KBL (verified by the recorded magnetic heading) and landed at a gross weight of 123,100 pounds (LB) [the maximum design landing weight is 123,899 LB]. Based on the landing weight and flap position, the landing reference speed (VREF) should have been approximately 142 knots. The approach speed was not recorded; however the computed airspeed was maintained at approximately 162 knots during the final approach with the autothrottle engaged which indicates that the approach speed was most likely VREF+20. From 900 feet RA until 75 feet RA, the descent rate (negative calculated vertical speed) was maintained at above 1000 feet/minute (fpm) with an average descent rate of 1250 fpm and maximum descent rate of 1400 fpm at time 3828 seconds. The glideslope deviation indicated the airplane was below the beam during the approach and the localizer deviation indicated that the airplane was either on or slightly right of the runway centerline (Figures 1 and 2). The calculated wind data were comparable to the airplane recorded ship system winds in magnitude, with more variation in the direction (Figure 2). However, both wind data sources indicate that the airplane was in a left quartering tailwind. Beginning at about time 3740 seconds at approximately 2000 feet RA, just as the airplane descended to capture the glideslope (not shown), the atmospheric conditions became turbulent with increased perturbations in computed airspeed, vane angle of attack, normal load factor and lateral acceleration, along with increased control wheel and column inputs to maintain the desired attitudes.

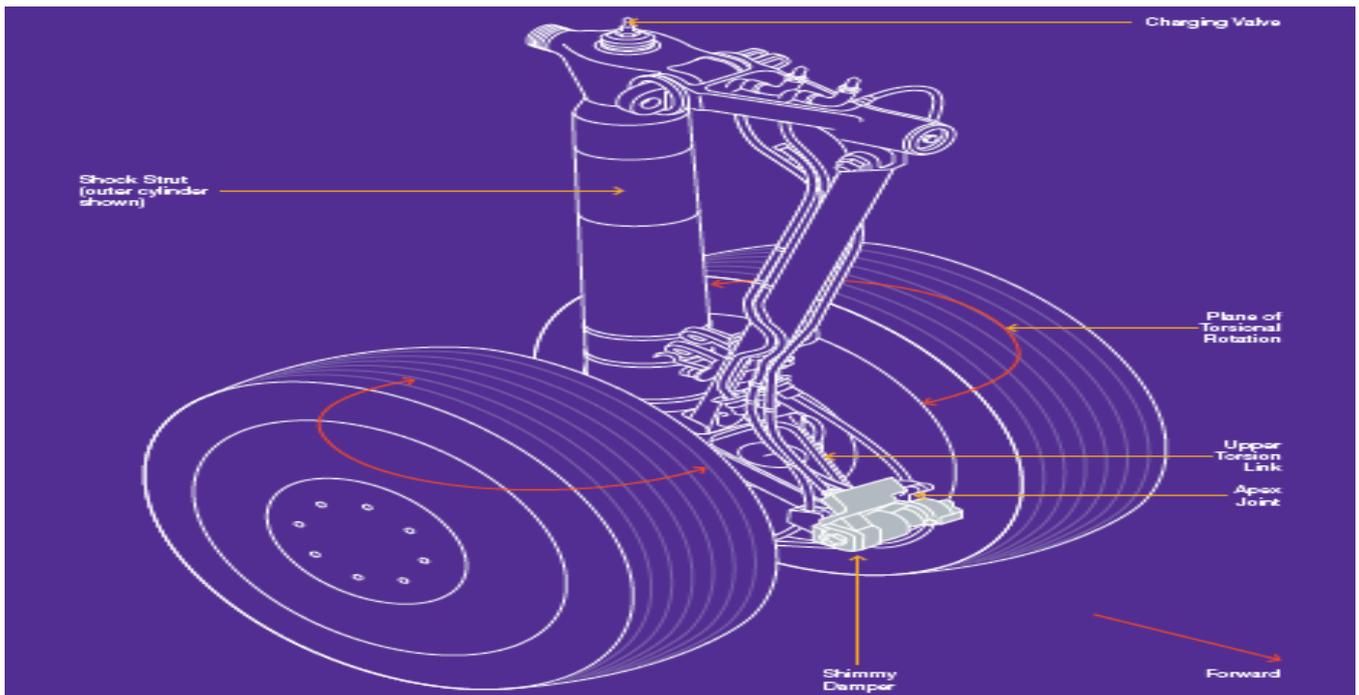
Due to the geometry of the torsion links, the shimmy damper is most effective when the landing gear strut is compressed in the ground mode. Lower touchdown descent rates increase the likelihood of a shimmy damper failure. It is important to note, however, that proper maintenance of the gear components is the best way to prevent shimmy damper failures. The possibility of landing gear shimmy events is greater at high altitude airports.

For shimmy to occur, the landing gear must have a force applied to it that excites this torsional vibration mode. The 737 has a vibration frequency of approximately 15 Hertz (Hz). Boeing engineers theorize that the force needed to initiate shimmy is probably an alternating drag force, such as if one tire touches down, causing a twisting motion of the inner cylinder in one direction and the second tire touches down a fraction of a second later, causing the inner cylinder to twist in the opposite direction. If the timing between the first tire and second tire contacting the runway is similar to the shimmy frequency, the gear can oscillate in the shimmy mode.

Boeing also recommends that pilots strive for a landing with normal sink rates with particular emphasis on ensuring that the auto speedbrakes are armed and deploy promptly at touchdown. An overly soft landing, or a landing in which the speedbrakes do not promptly deploy, allows the landing gears to remain in the air mode longer, which makes them more vulnerable to shimmy. This is especially true when landing at airports located at higher elevations, where the touchdown speed is increased.
