**KOMITE NASIONAL KESELAMATAN TRANSPORTASI
REPUBLIC OF INDONESIA**

Aircraft Accident Investigation Report

PT. Wings Abadi Airlines

ATR 72-212A; PK-WGW

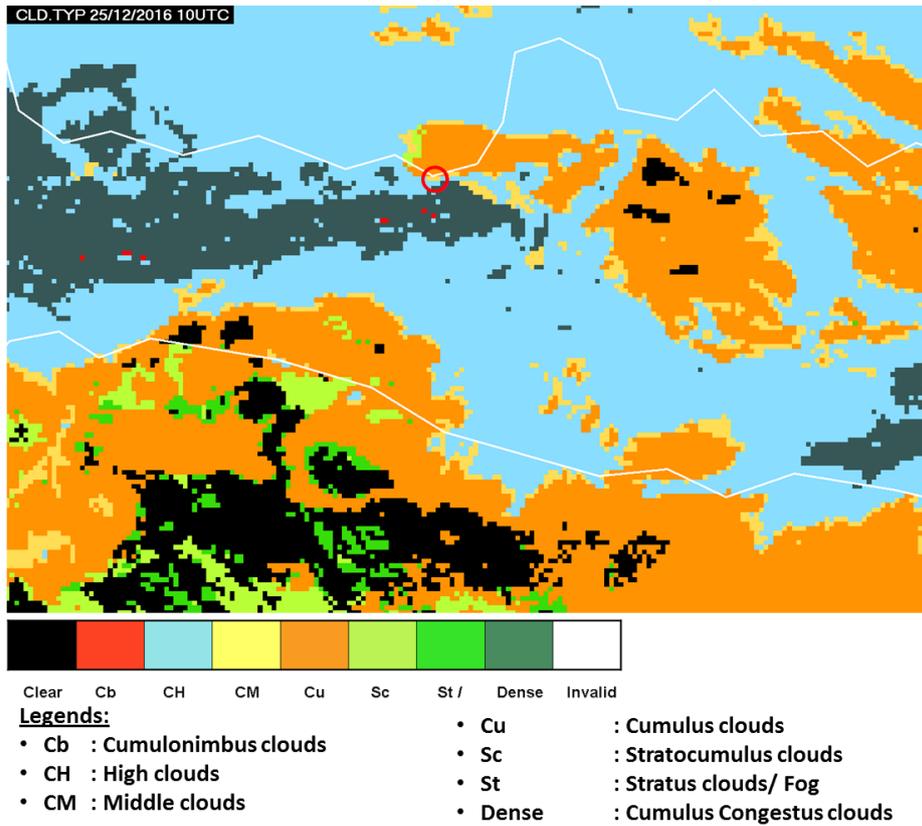
Figure 4: Satellite image at 1000 UTC (Copyright of BMKG)

The satellite images provided by *Badan Meteorologi Klimatologi dan Geofisika* (BMKG – Bureau of Meteorology, Climatology and Geophysics of Indonesia) at 1000 UTC, 1100 UTC and 1200 UTC. The images indicated development of Cumulus Congestus clouds (towering cumulus) around Semarang during the accident flight (red circle). The cloud was classified as low clouds, which may produce precipitation and often release abundant rain in the form of showers⁹.
