Technical Report A-003/2017

Accident occurred on April 10, 2017,
to the Boeing 757-200 aircraft operated
by Jet2.com, registration G-LSAI,
during the landing manoeuvre
at Alicante-Elche airport (Spain)

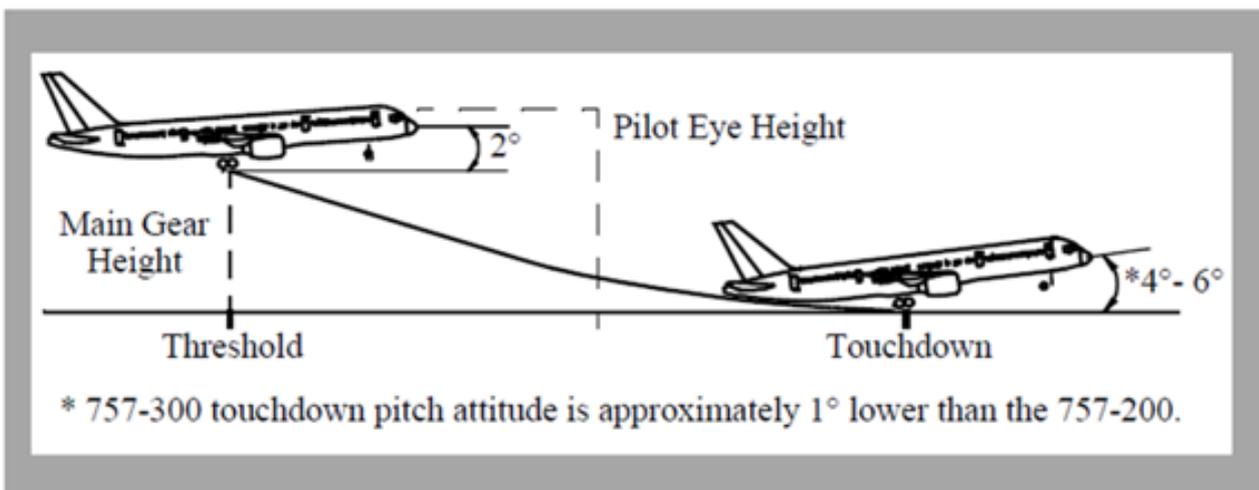
Fig. 6. Pitch attitude on landing.

Landing attitude close to 5° is identified as within the normal range with the correct reference speed (fig 6). However, the manual specifies (fig 7) that with a VREF-7 kt (119 kt) touchdown and with a weight of 181084 lb (82138 kg) the touchdown attitude would be close to 9°.
