**Banjul Accord Group**  
**Accident Investigation Agency (BAGAIA)**

# AIRCRAFT ACCIDENT REPORT

CVK/2017/07/29/F

Report of the Accident involving CAVOK Airlines CVK  
7087 AN-74TK-100 Aircraft registered UR-CKC which  
occurred at Sao Tome International Airport, Sao Tome  
on 29<sup>th</sup> July, 2017

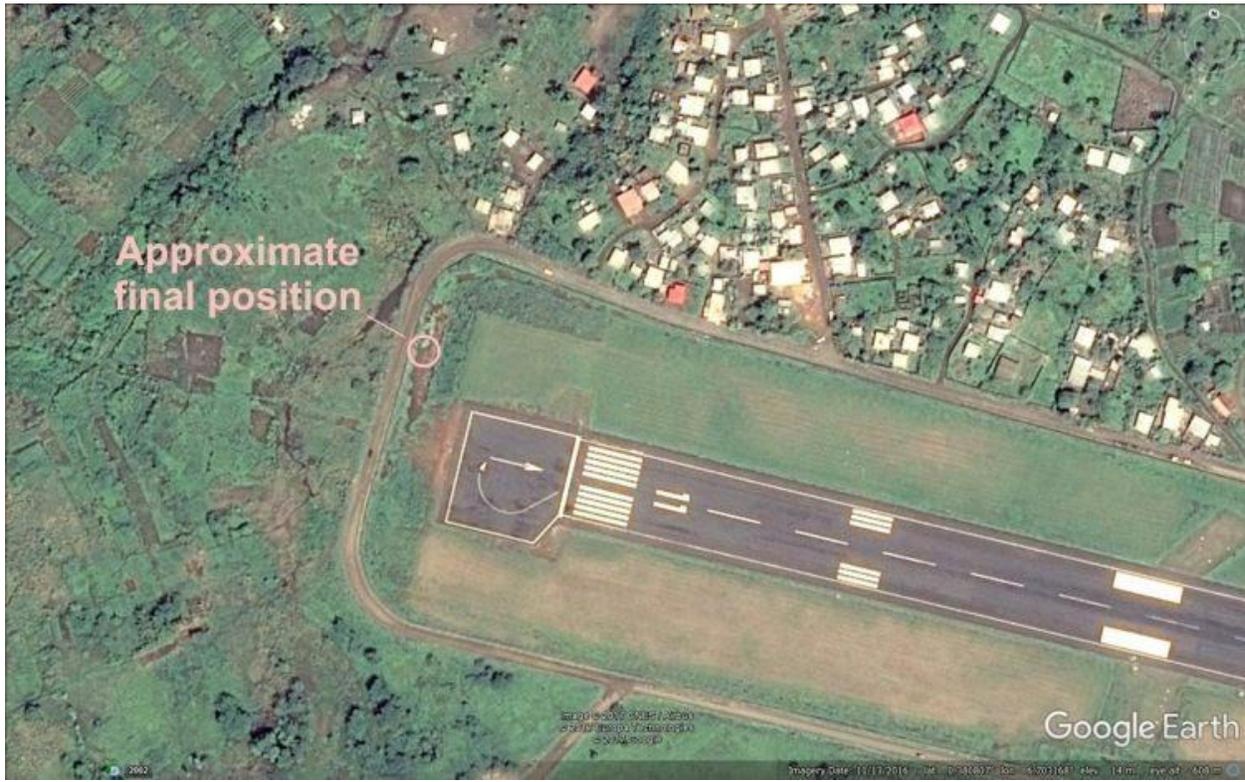
**Figure 3: Aerial view of the Aerodrome**

Runway inspection is usually carried out by the airport fire service personnel before any landing or take-off. At 0720hrs on the day of the accident, the runway was inspected for departure of STP Airways, STP 508.

Aeronautical Information Publication on the aerodrome is that "Birds may at times flock on the grass around the runway. If large concentrations of birds are seen on or near aerodrome, pilots of aircraft will be so informed by ATS." As part of its wild life control programme, the airport authority uses a 12-gauge firearm for elimination of animals while it employs scarecrow and a 12-gauge shot gun to scare and eliminate birds respectively.

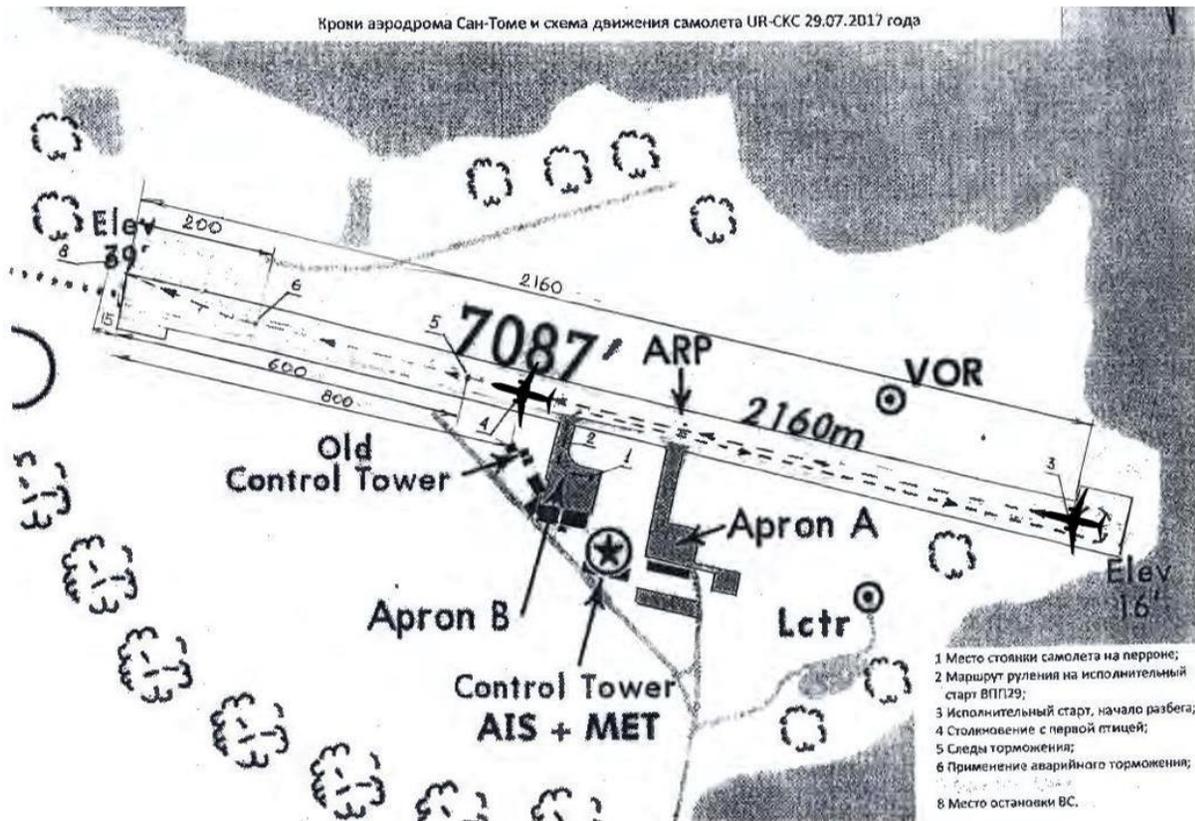
**Figure 19: Runway configuration showing positions of aircraft during the attempted take-off roll**

The Captain took control of the aircraft and requested the Flight Engineer to check if the landing lights were ON and to monitor the engine parameters. The Captain further stated that he assessed the situation within 4 - 5 seconds and decided that the best option for the crew was to abort the take-off. The Captain immediately initiated a rejected take-off, instructing the Flight Engineer to apply the thrust reversers. The rejected take-off was initiated at a speed of 220 km/h, about 5 seconds after sighting the birds.

The decision not to continue the take-off could have been made when the flight crew observed that the runway surface appeared to be rising as the aircraft was accelerating towards the take-off speed, before they sighted the flock of birds. The investigator believes that the pilot intended to continue the take-off despite the birds seen and the runway factor.
