**FINAL REPORT**

**AIC 17-1004**

## **CONTROLLED FLIGHT INTO TERRAIN**

**P2-ISM**

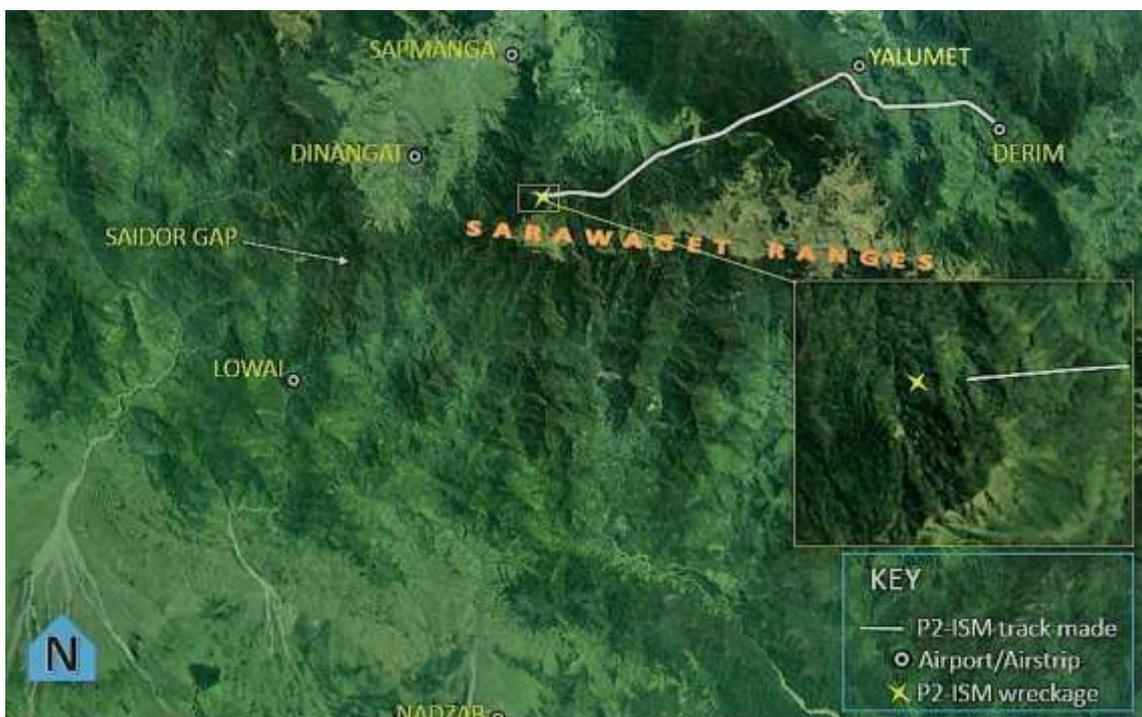
On 23 December 2017, at 00:10 UTC<sup>1</sup> (10:10 local), a Britten Norman BN-2A Islander aircraft, registered P2-ISM (ISM), owned and operated by North Coast Aviation, impacted a ridge, at about 9,500 ft (6°11'29"S, 146°46'11"E) that runs down towards the Sapmanga Valley from the Sarawaget Ranges, Morobe Province. The pilot elected to track across the Sarawaget ranges (See figure 1), from Derim Airstrip to Nadzab Airport, Morobe Province, not above 10,000 ft. The track flown from Derim was to the northwest 6.5 nm (12 km) to a point 0.8 nm (1.5 km) west-southwest of Yalumet Airstrip where the aircraft turned southwest to track to the Saidor Gap. GPS<sup>2</sup> recorded track data<sup>3</sup> immediately prior to the last GPS fix showed that the aircraft was on a shallow descent towards the ridge. The aircraft impacted the ridge about 150 m beyond the last fix.

**Figure 1: Aircraft track and wreckage location**

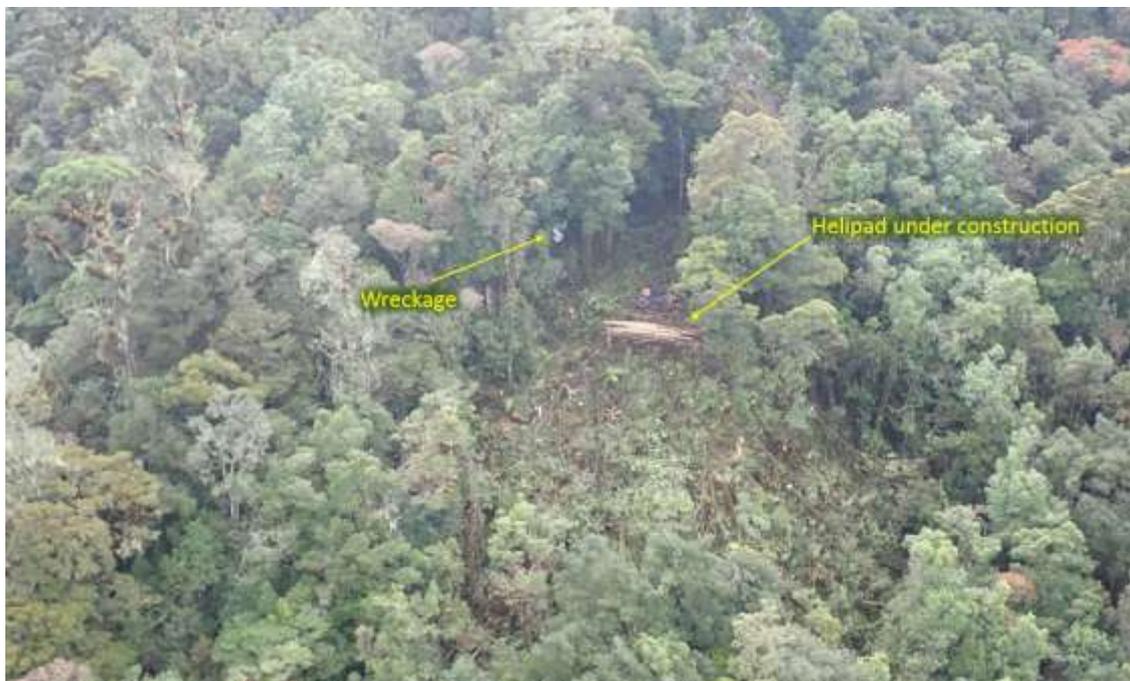
Figure 5: Accident site with respect to the rescue team constructed helipad<sup>4</sup>

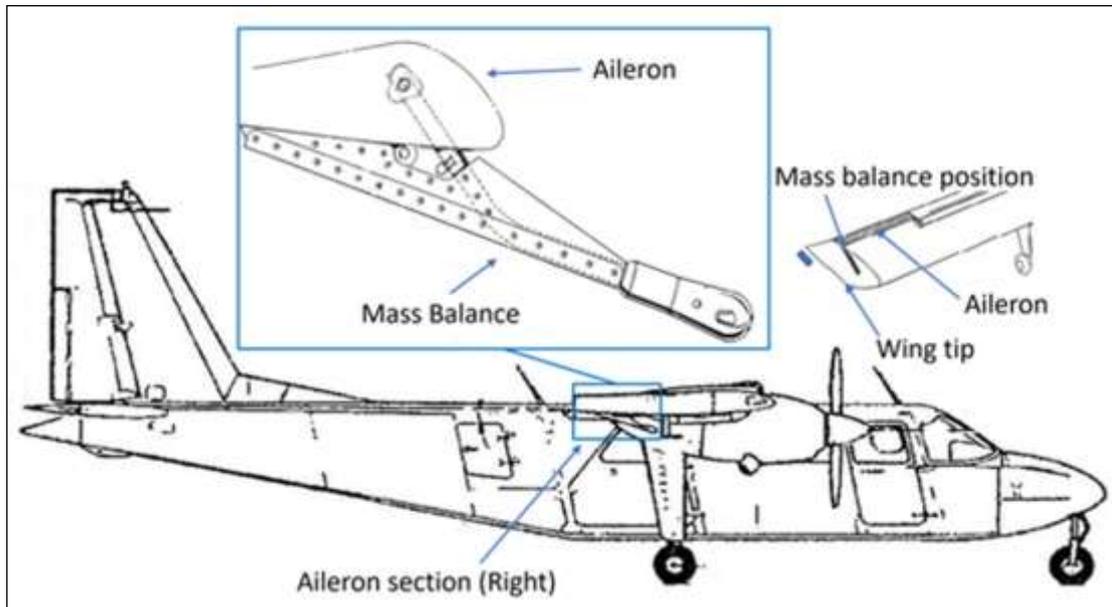
To avoid flutter<sup>9</sup> during airflow across an aileron, counter-balances are installed. The Britten Norman Islander has mass balances installed at the outboard end of each aileron (see figure 6). This mass balance protrudes down and forward near the wing tip.

The right aileron separated from the wing during the initial impact with trees. It is likely that the aileron separated when the mass balance became caught in a tree branch when it initially clipped a tree on the ridge.

Figure 6: Britten Norman Islander aileron design
