Aircraft Accident Investigation Board

Final Investigation Report

State File Number: A961127EPFQF
Type of Occurrence: Accident
Date of Occurrence: 16 Feb 2018
Place of Occurrence: Mashhad Airport, I.R Iran
Aircraft Type: Fokker 100
Registration: EP-FQF
Operator: Qeshm Airlines

Date of Issue: 24 Dec 2018

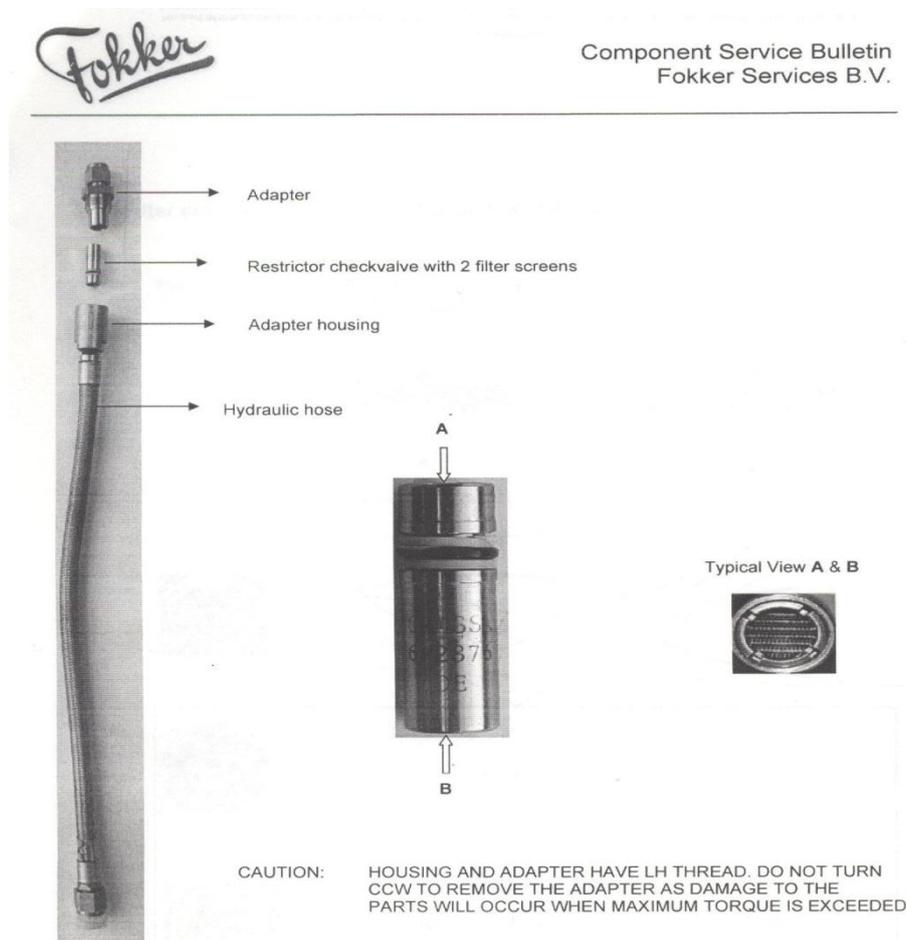
Figure 11- Instruction Scheme of CSB 32-026

On the latest “C” check based on AD 2015-0077 & SB NO; F100-32-166 & SB CSB-32-026 Landing Gear – Hydraulic Hose Restrictor Check Valve Screen of restrictor were inspected without any abnormalities.

The bulletin introduced a one time inspection of Screen filter which was done by Hydraulic Shop and reinstalled by Qeshm Air technical staff.

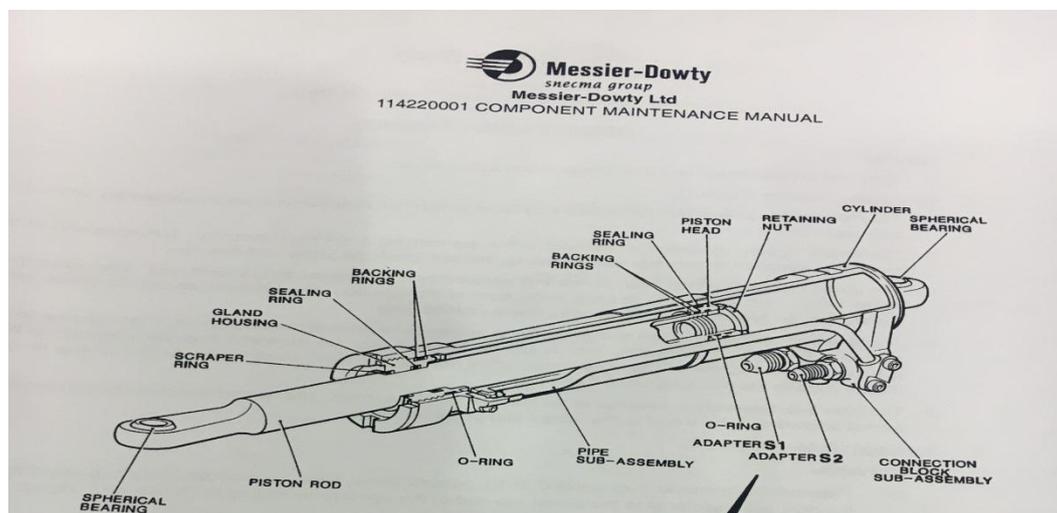
Figure 14- Scheme of L/G Retracting Actuator

The retract actuator of left main landing gear was removed from the aircraft and was opened and analyzed in "Iran Air" hydraulic shop based on its CMM. There was some white pollution as sediment in the hollow cylinder which was seen on the check valve. All internal rings and spacer were normal without any cut in shapes so the black particle was not suspected to have originated from cylinder parts accordingly.
