Aircraft Accident Investigation Board

Final Report

State File Number: A961129EPATS
Type of Occurrence: Accident
Date of Occurrence: Feb 18th 2018
Place of Occurrence: Near Yasouj Airport
IR of IRAN
Aircraft Type: ATR 72-212
Registration: EP-ATS

Date of Issue: 15 Jun 2020

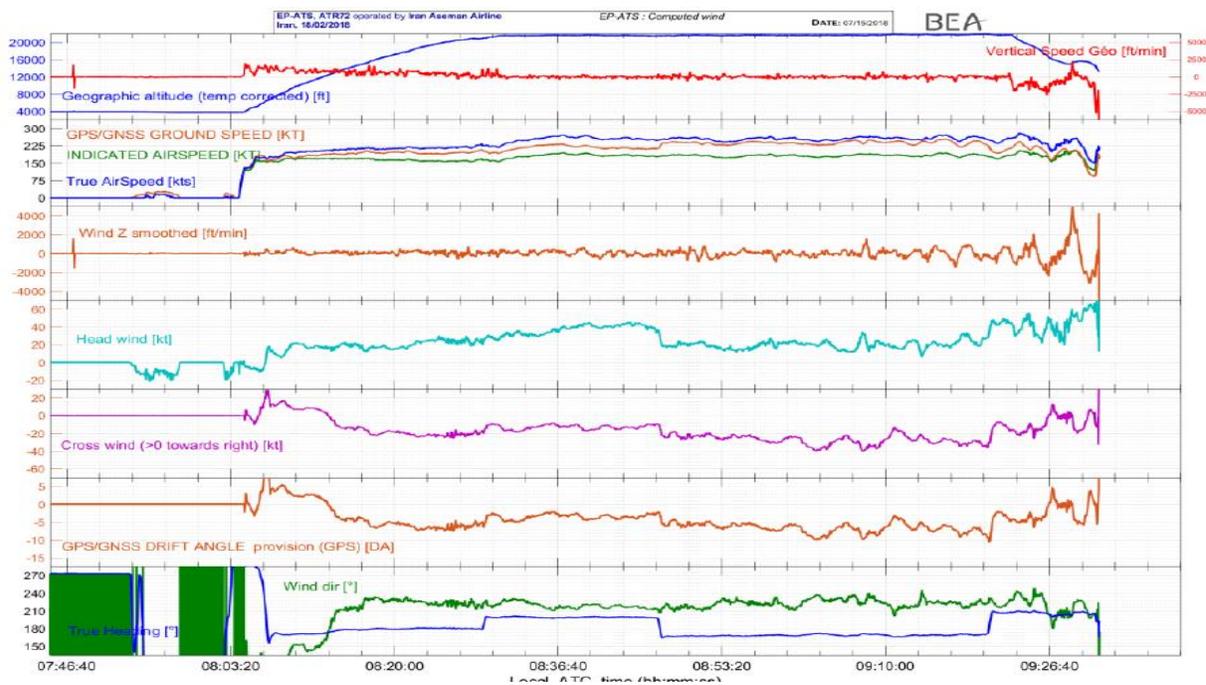
Figure No. 10 Computed wind

The computed wind showed consistencies between the true heading, the true wind direction, the head wind, and the cross wind, the TAS, the GPS/GNSS Ground Speed and the computed drift angle:

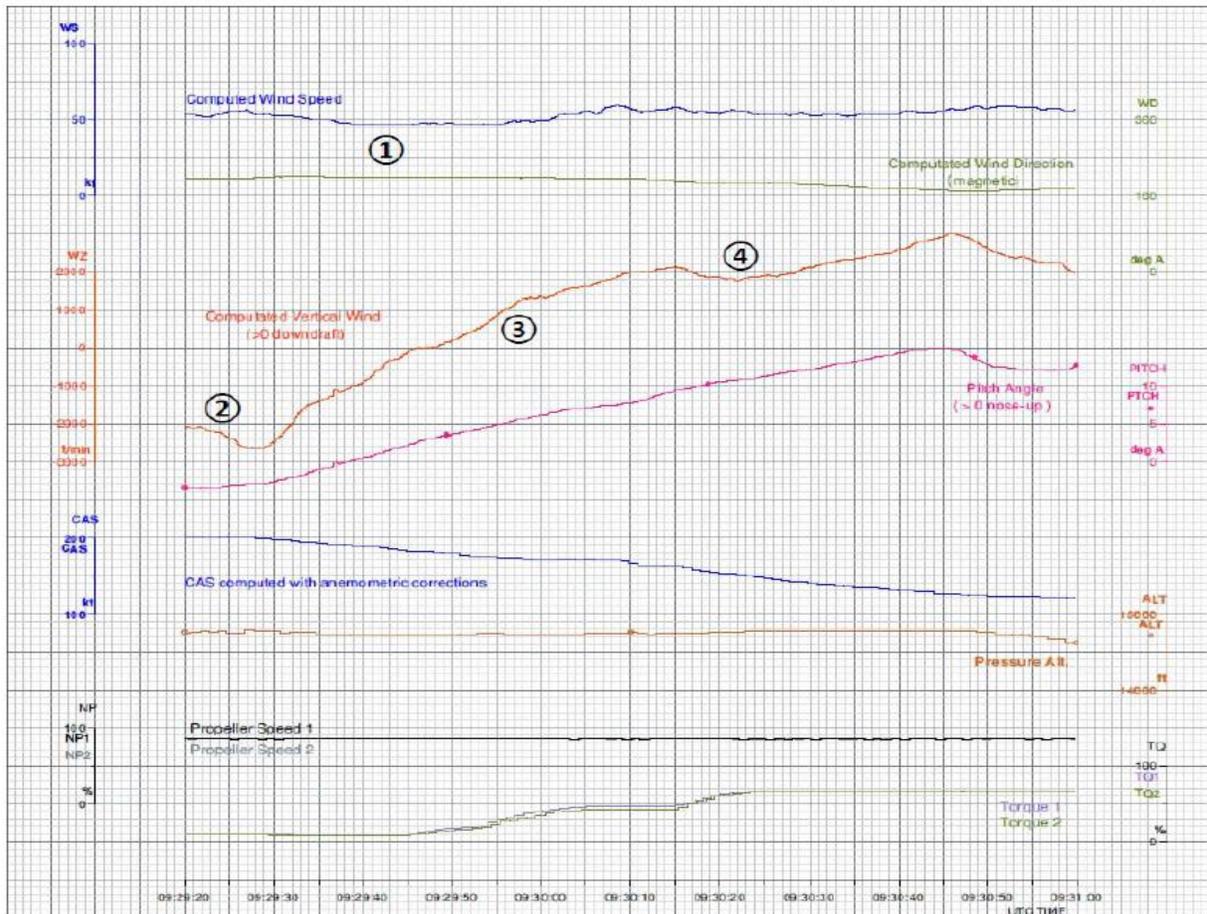
Figure No 11 Wind computation by the manufacturer (9 h 29 min 20 s to 9 h 31 min 00 s)

From 09:31:18 to 09:31:30 UTC:

- The computed wind speed increased up to around 70 kt and the computed wind direction slightly decreased to about 195°.
- The computed vertical wind decreased.

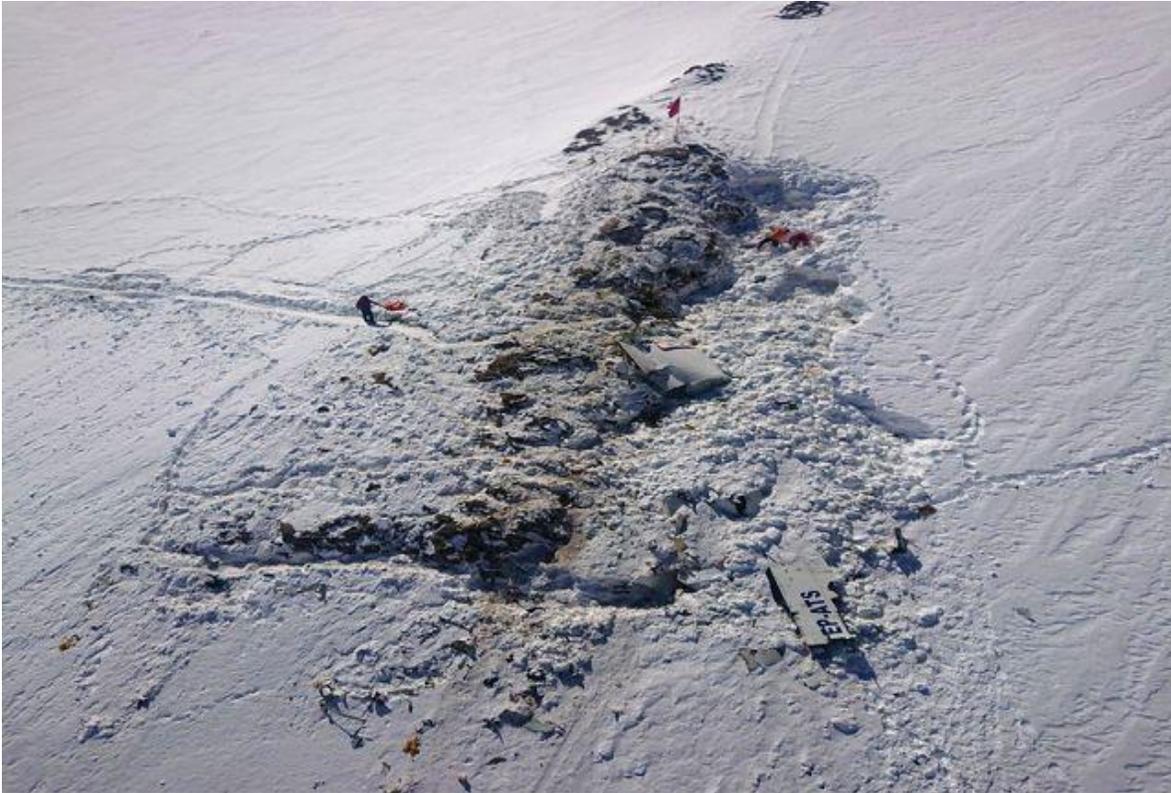
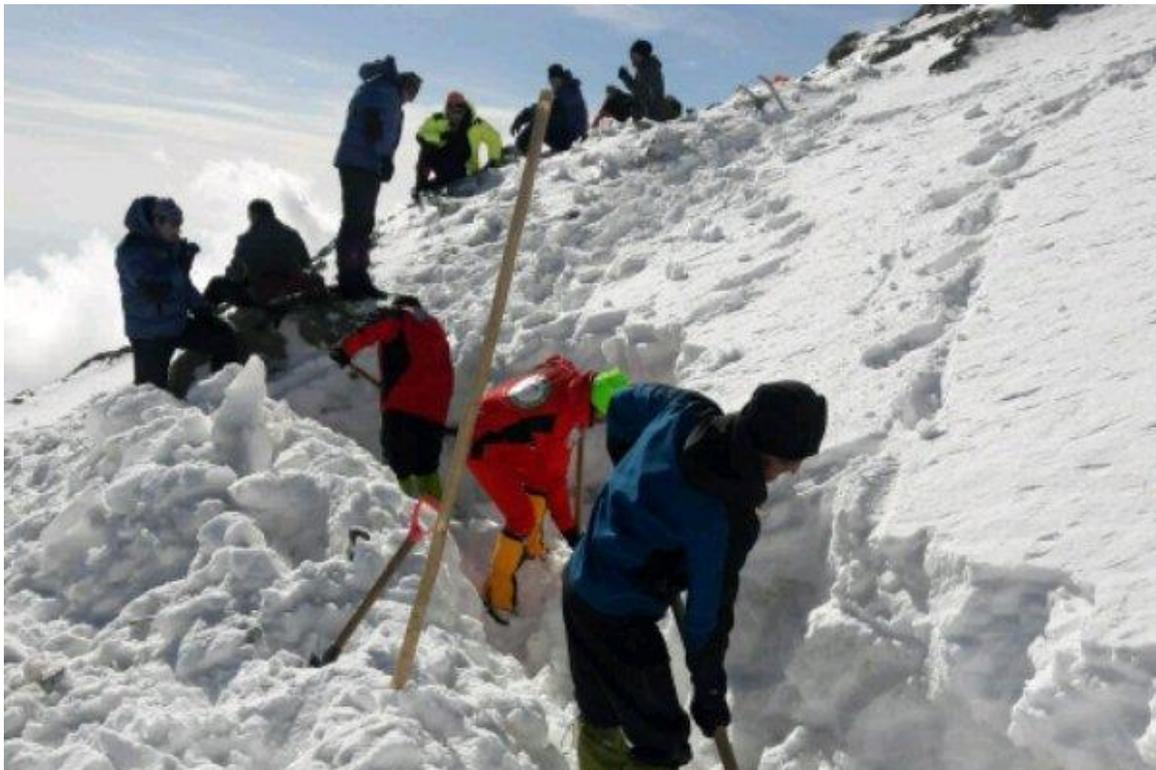
Figure No. 15 Recovery of Victims on Accident Site:

Aircraft collision with the terrain caused the immediate death of all the aircraft’s occupants. Due to the severity of the aircraft collision with the mountain, the bodies of the occupants are completely destroyed, and according to geographical conditions (Mountains) and severe weather phenomenon, including heavy snow, collecting of victims was so hard.

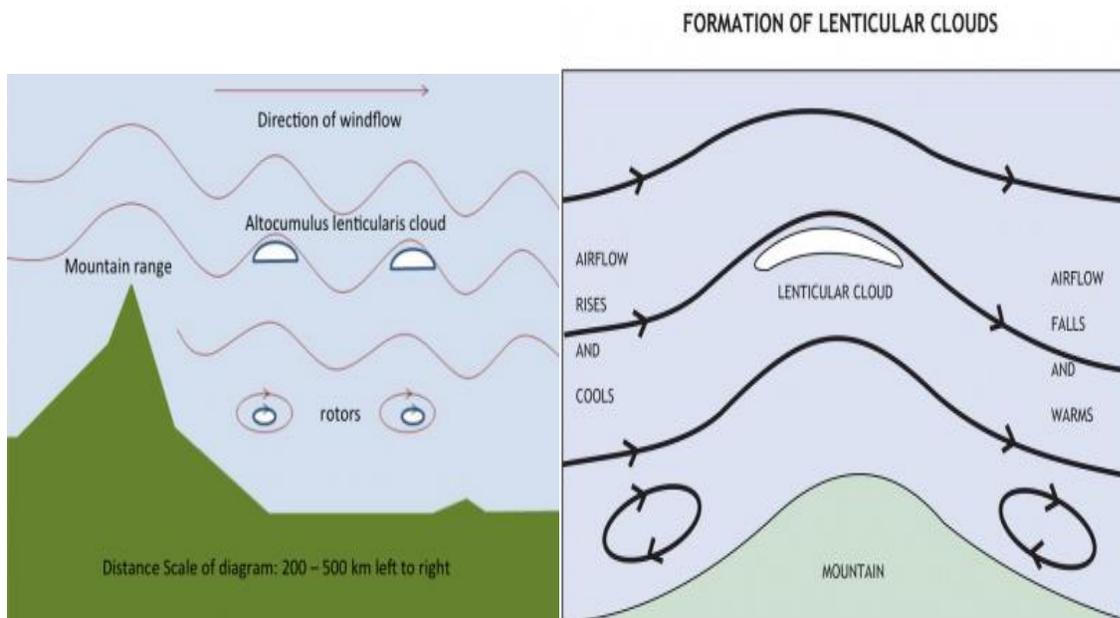
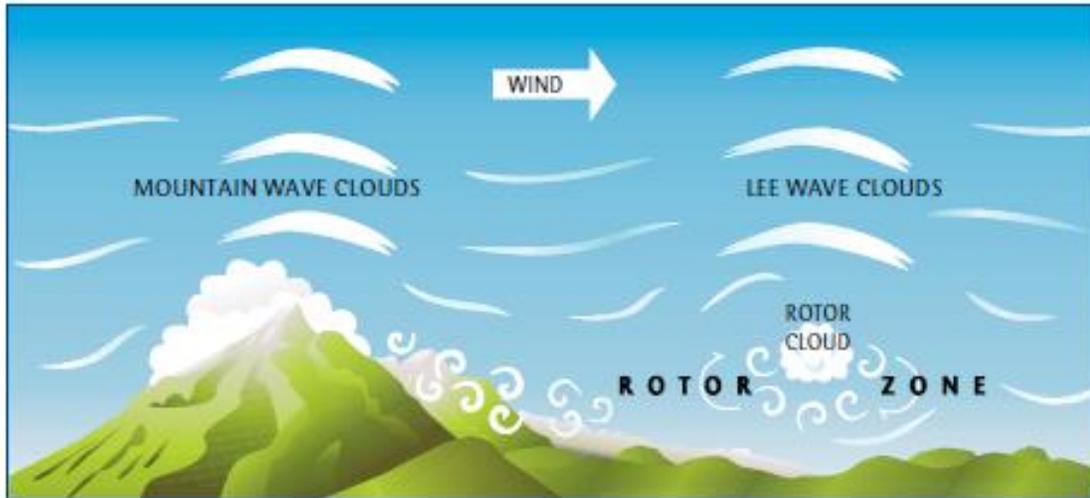
Figure No. 18 Effect of Mountain Wave

Vertical air stream (up & down drafts) with turbulences can reach more than 3,000 ft/min. Mountain Waves are associated with severe turbulence, strong vertical currents, and icing. The combination of these strong vertical winds and surface friction may cause rotors to form beneath the mountain waves, causing severe turbulences with high load and acceleration on the aircraft. Usually, the pilots should be careful for speed monitoring and stall prevention.

The aircraft tracking and FDR analysis showed the flight crossed the Up & down draft. The updraft and downdraft computed wind values were confirmed by the aircraft attitude. Following the engagement of the altitude hold mode, an updraft wind made the autopilot request a pitch down attitude, while a downdraft wind made the autopilot request a pitch up attitude. The reactions of the autopilot were consistent with maintaining the aircraft at the target altitude. The crew increased the engine power from 47% to 73% TQ by moving the PL up to the notch. However, despite the continuous decrease of the indicated airspeed, the crew did not increase the engine power until its full capacity (no change of the power management, no selection of a propeller speed of 100 %, no move of the PL beyond the notch position). The selected power (max power with the engine settings at that time: 2132 SHP) is more than 22 % below the maximum power of the engine (max power with PL at the ramp and propeller speed at 100%: 2750 SHP). This selected engine power was not sufficient to stop the decrease of the airspeed. The aircraft performance was not enough against high rate of down draft (about 3200 ft. /min). So, near the mountain the aircraft experienced significant reduction in airspeed and wing lift factor as effect of down draft.

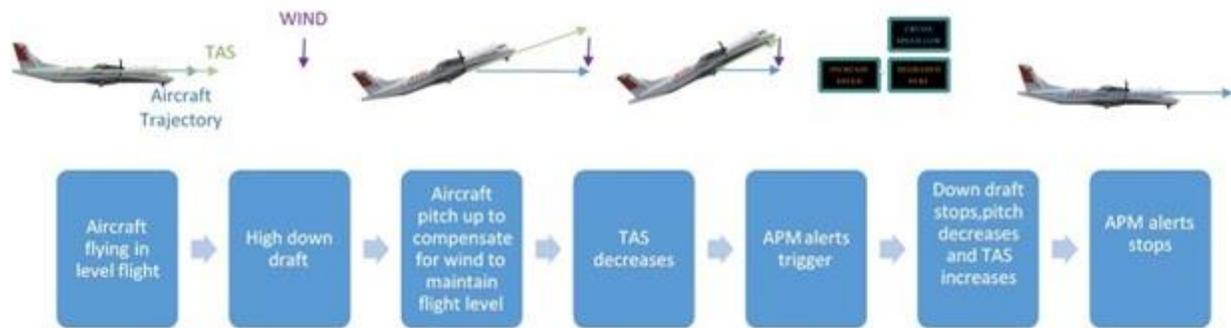
Figure 24. Illustration of wind effect on APM calculation

As a conclusion, the APM simulation tends to show that the alerts that would have triggered are linked to a decrease in performance due to external conditions (wind gradient) rather than icing, as illustrated in the following Figure:

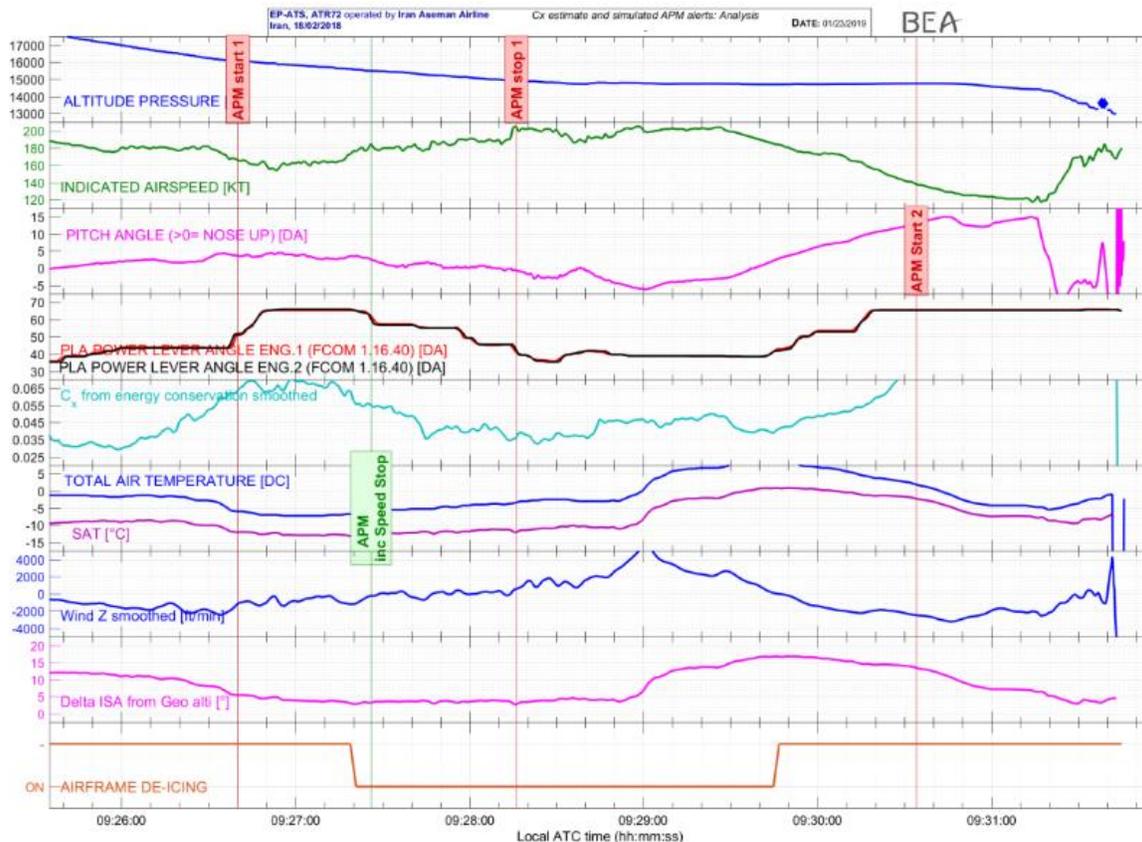
Figure 26. Simulated APM alerts - Analysis

At that time, the anti-icing level had been previously engaged. APM alert would have then been triggered. APM calculation uses smoothed values over a rolling average of 60 s. The true increase of the C_x occurs before any APM alert triggering. During the flight of the event, the C_x increase leading to the first simulated APM alerts started at 9 h 26 min 00 s, the C_x increase leading to the second simulated APM alert occurred at 9 h 30 min 00 s.

The first simulated APM alerts (both Degraded Performance and Increase Speed) would have been triggered at 9 h 26 min 40 s. however the pilot used more power accordingly and degraded situation was finished on 09:27:26 s. The first simulated APM alerts:
