# Report A-012/2018

Accident involving a Cessna 525C – CJ4,  
registration EC-MOQ, operated by Aluminios  
Cortizo, at the Santiago de Compostela Airport  
(La Coruña) on 4 May 2018

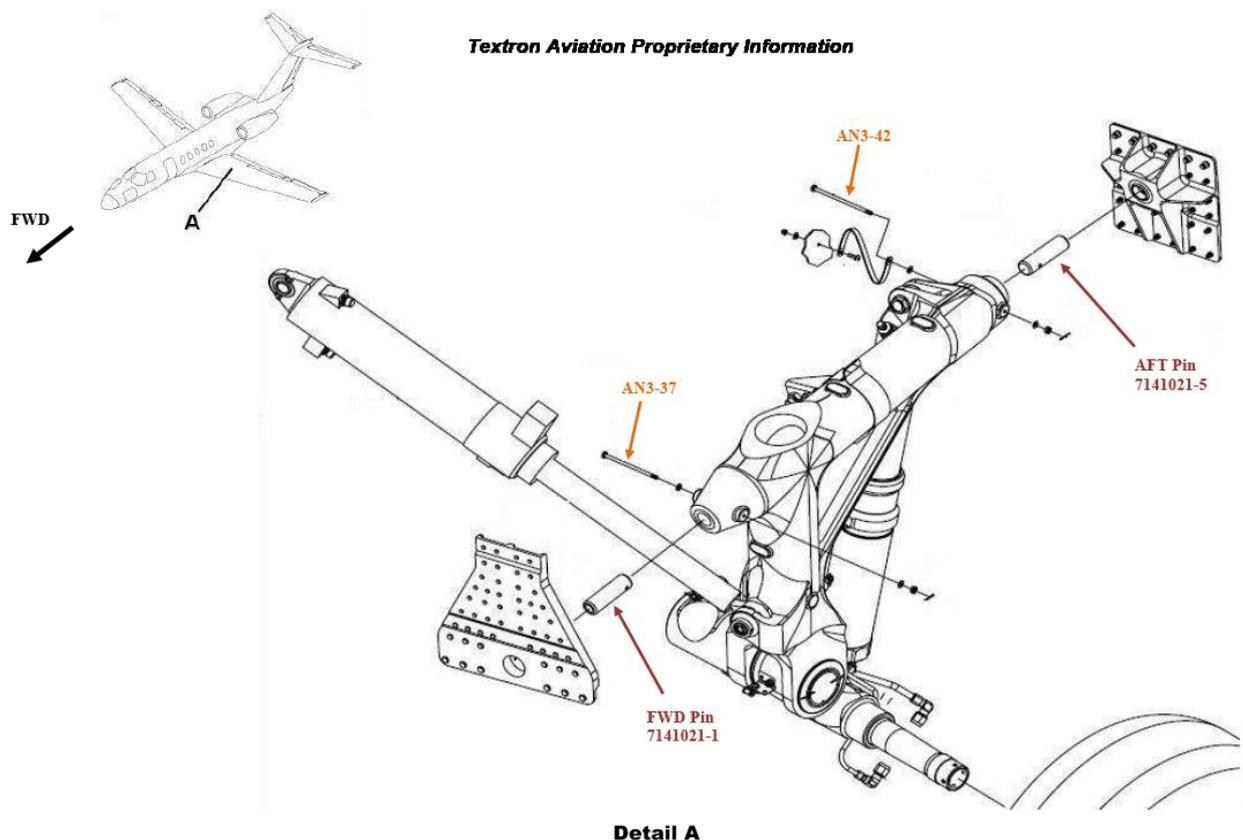
Diagram 3 – Main gear assembly.

- The bolt, AN-3-42, of the rear support on the left side (side and trunnion pin that caused the accident), was broken at the threaded end and the other end had broken off. It contained a gray sealant residue over another black sealant. This was the only bolt of the four with residue from two different sealants, which indicates a repair of the connection with a bonding jumper on this pin. According to the maintenance history, it was replaced in November 2017.

- As to whether the aft trunnion pins were originally installed correctly or incorrectly, the presence of two adjacent surfaces with contact/wear marks with the fitting, analyzed using penetrant liquid tests, indicates that these trunnion pins had been installed correctly at some point prior to their last installation.
