**AIRCRAFT ACCIDENT INVESTIGATION**

**CONTROLLED FLIGHT INTO TERRAIN**  
**INVOLVING**  
**EAST AFRICAN SAFARI AIR EXPRESS LTD**  
**TEXTRON AVIATION INC.**  
**CESSNA 208B GRAND CARAVAN,**  
**KENYAN 5Y-CAC**  
**THE ABERDARE RANGES, KENYA**  
**05 JUNE, 2018**

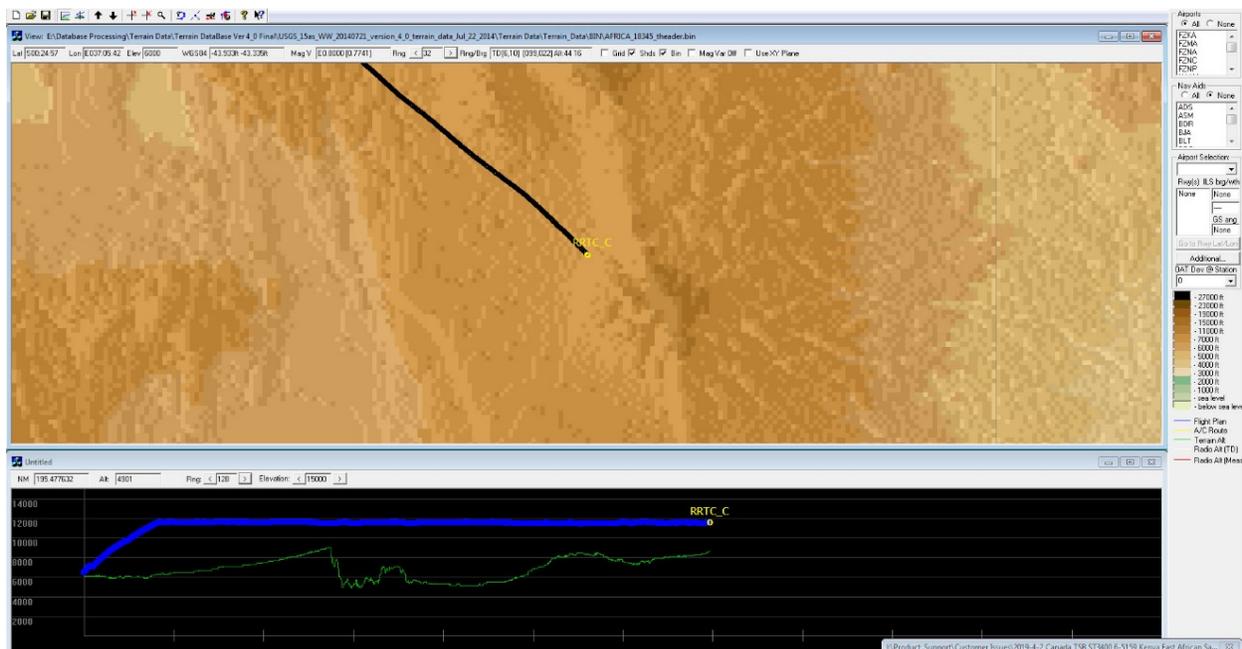
Figure 1: Elevation profile of 5Y-CAC from Kitale to the accident location against the terrain

The aircraft took-off from Kitale Airstrip (HKKT) at 16.05 hours and set course to Jomo Kenyatta International Airport (HKJK) after climbing to FL 110 with ten onboard. Once established, there were slight peripheral variations in groundspeed and track. The aircraft Flight Level was sustained at 110 with some occasional deviations. Aircraft height above ground level (AGL) varied between 1102 feet and 4187 feet. One minute before its impact with the cliff, the aircraft was at 11,100 feet or 3000 feet AGL, 159 knots ground speed, and tracking radial 338 NV. Immediately before radar signal was lost, the elevation of the highest ground level was 12876 feet, the aircraft altitude was 11,200 feet, the ground speed was 156 knots, and track was radial 339 NV.

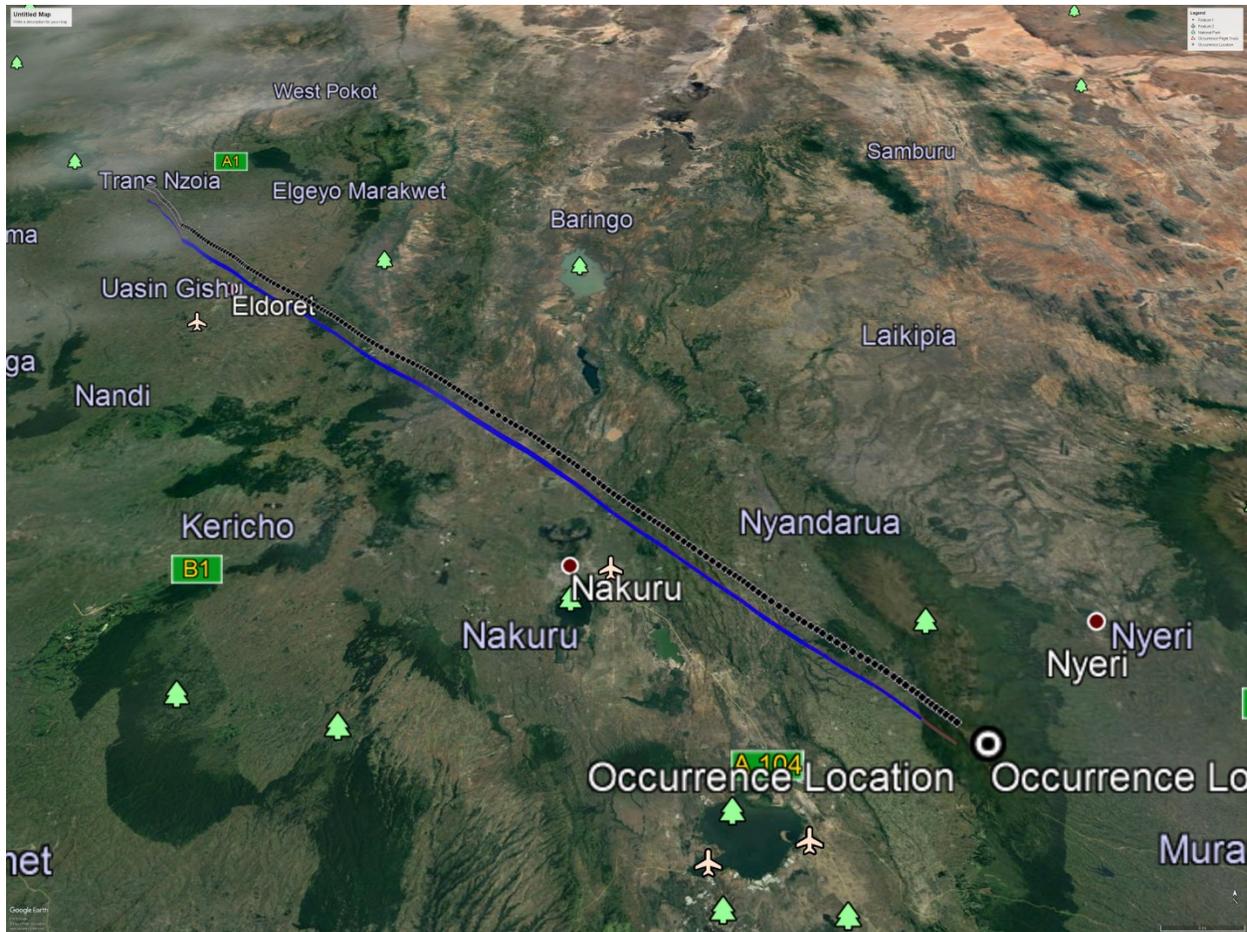
Figure 2: Aircraft Track from Kitale to the Accident Site

The radar system transmits information including aircraft position in relation to NV VOR, Flight Level or altitude, groundspeed, vertical speed and heading. Information retrieved from the GPS captured the last recorded time, date and location as 14:00:52, on 06/05/2018 and elevation 3555.57 metres. The aircraft impacted the bamboo-covered terrain at an elevation of 3,645 metres at 0.36°56''S 36 42'44'' where the wreckage was sited.

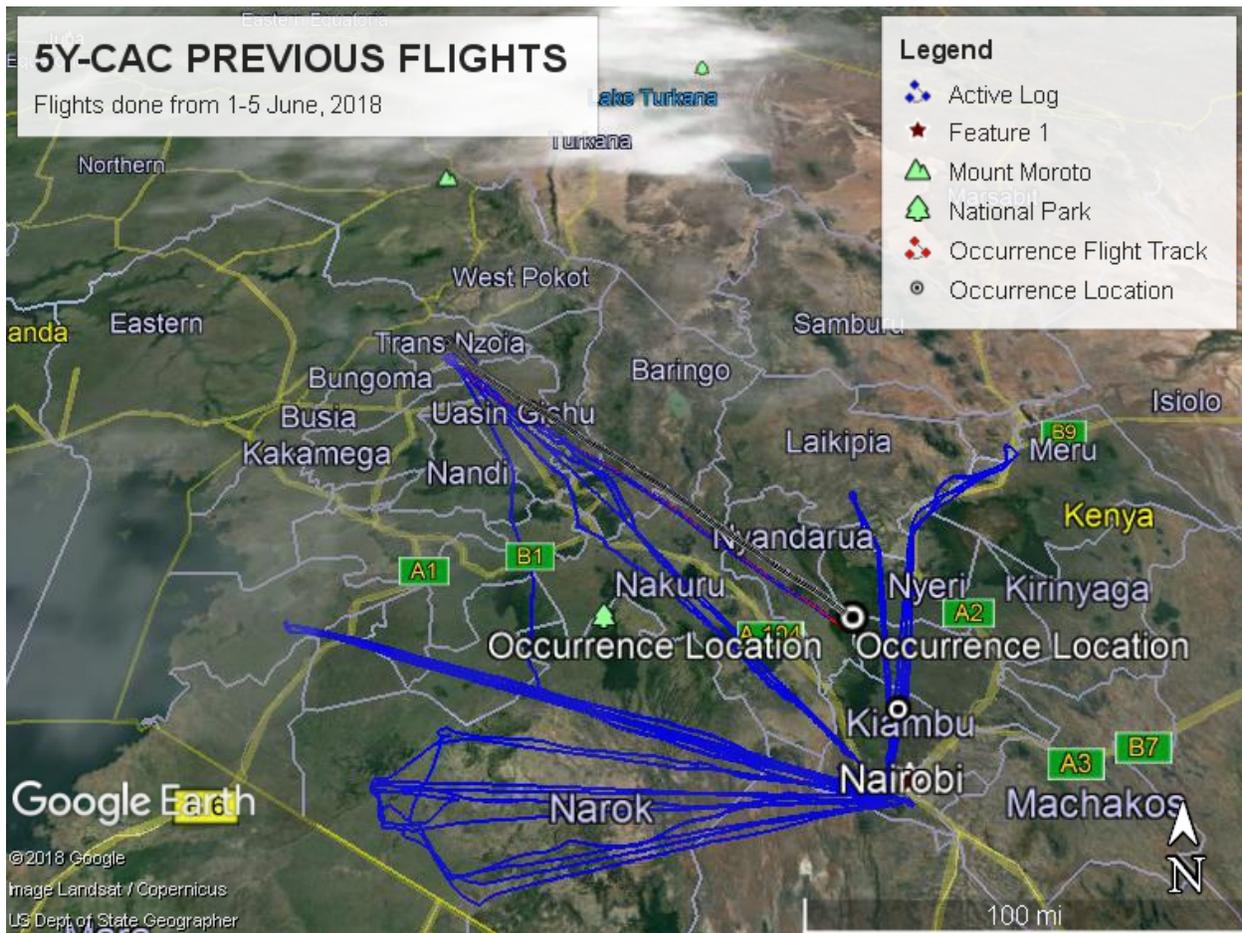
Figure 5: Aircraft Tracks depicting previous flights prior to the accident flight

Flysax operates a daily scheduled flight from Wilson airport, Nairobi to Kitale and back to Wilson airport, Nairobi. The accident flight was delayed because of the prevailing weather conditions of the day that necessitated delays in various scheduled flights of the day. The two passengers onboard EX302 from Kitale were scheduled for an international flight at JKIA. Due to the delay of the flight, Flysax elected to fly direct to JKIA instead of the usual Wilson airport in order to enable the two passengers to arrive in time for the international flight.

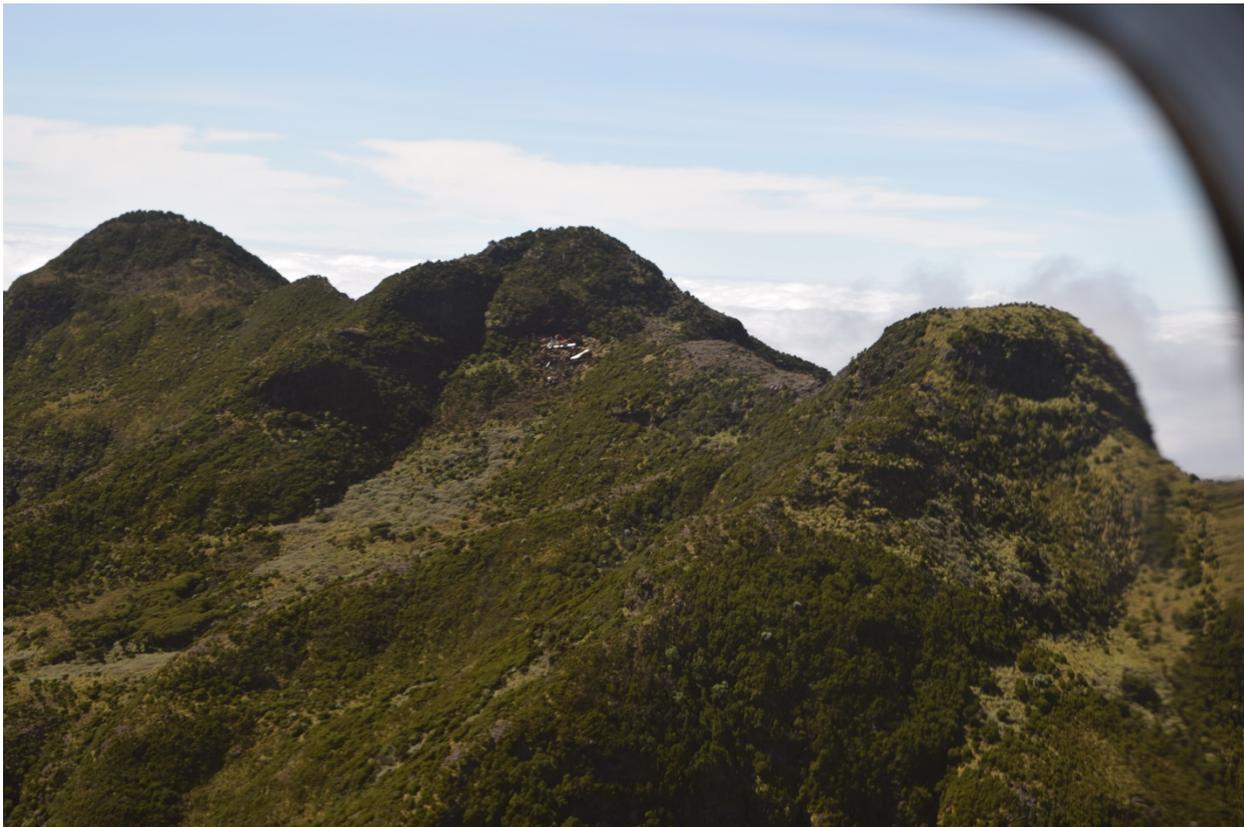
Figure 18: Accident site depicting three summits

The general description of the site of the accident depicts three summits; the Elephant hill, the Kinangop and Oldonyolesatima with their respective elevations of 12,145, 12,815 and 13,120 feet above mean sea level

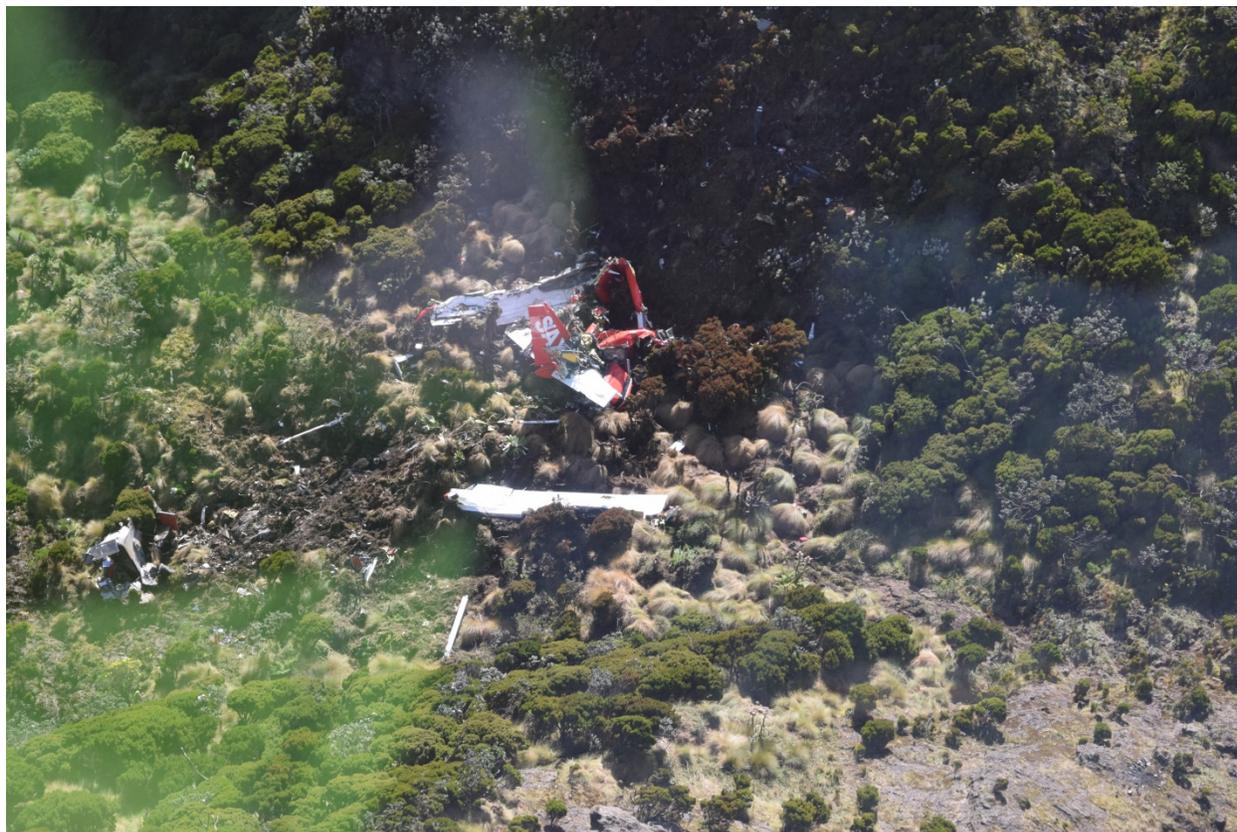
Figure 19: Aerial view of the accident site

The first point of impact was at an elevation of 3,645 metres asl, below the top of the Elephant peninsula. First ground impact was by the landing gear and the belly cargo pod followed by the propeller, all of which separated from the aircraft on impact. The aircraft continued and impacted the rising slope and came to rest in upright position. The cockpit was crushed, and the forward passenger cabin was distorted, with the forward cabin bulkhead mostly dislodged from its attachments. The aircraft seemed to have impacted the obstacle in a straight and level configuration.

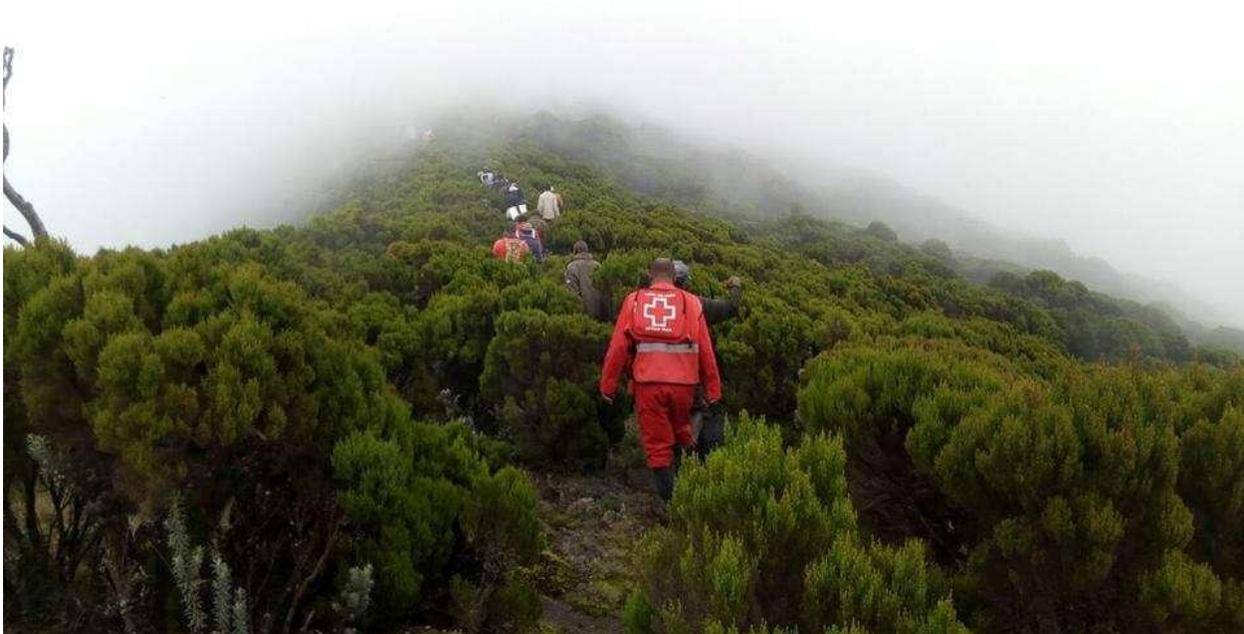
**Figure 21: The SAR team accessing the Elephant hill where the crash occurred**

The search and rescue exercise resumed at 6.00 am on 6<sup>th</sup> June, 2018 with a command post being set up at Njambini Primary School for appropriate coordination. The SAR exercise which was being done by both aerial and ground was greatly hampered by rainfall, forest cover, rugged topography, and limited visibility due to fog.
