FINAL REPORT OF L-410 UVP UR-TWO

L-410 UVP (UR-TWO) Crashed, On 9, Sept 2018

At Yirol, Eastern Lake State, Republic Of South Sudan.

FINAL REPORT OF L-410 UVP ACCIDENT IN YIROL.

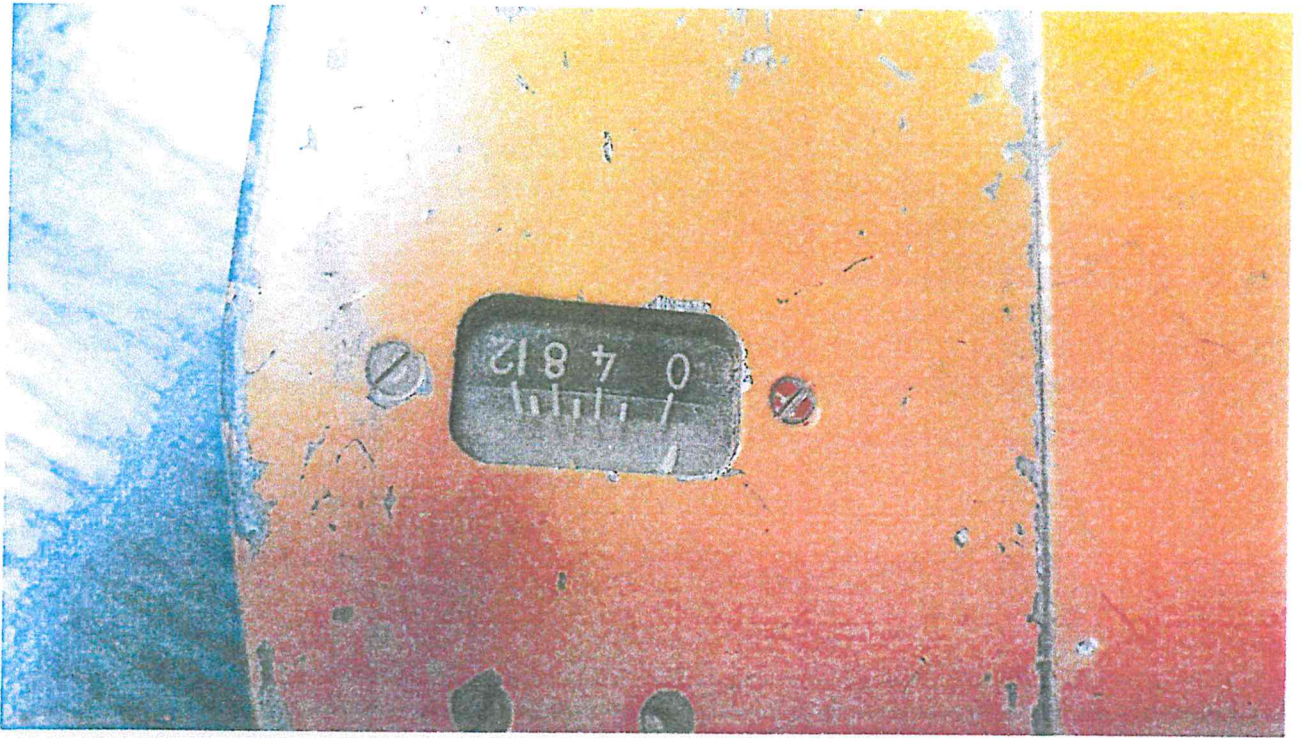
As a result of analysis performed by the laboratory experts, it was found that the accident data is missing on the photosensitive film because, by the time of the accident, the photosensitive film inside the cassette had come to its end. As a result of the analysis, experts concluded that the lack of flight data information does not provide a chance to determine the cause of the accident by this flight data recorder.
