FINAL REPORT

Final report of the investigation into the probable causes of the accident with the KLM Cityhopper flight KL433, Saab 340B, PH-KSH at Schiphol, Amsterdam Airport on 4 April 1994, conducted by the Netherlands Aviation Safety Board, composed of:

Hoofddorp, October 1995

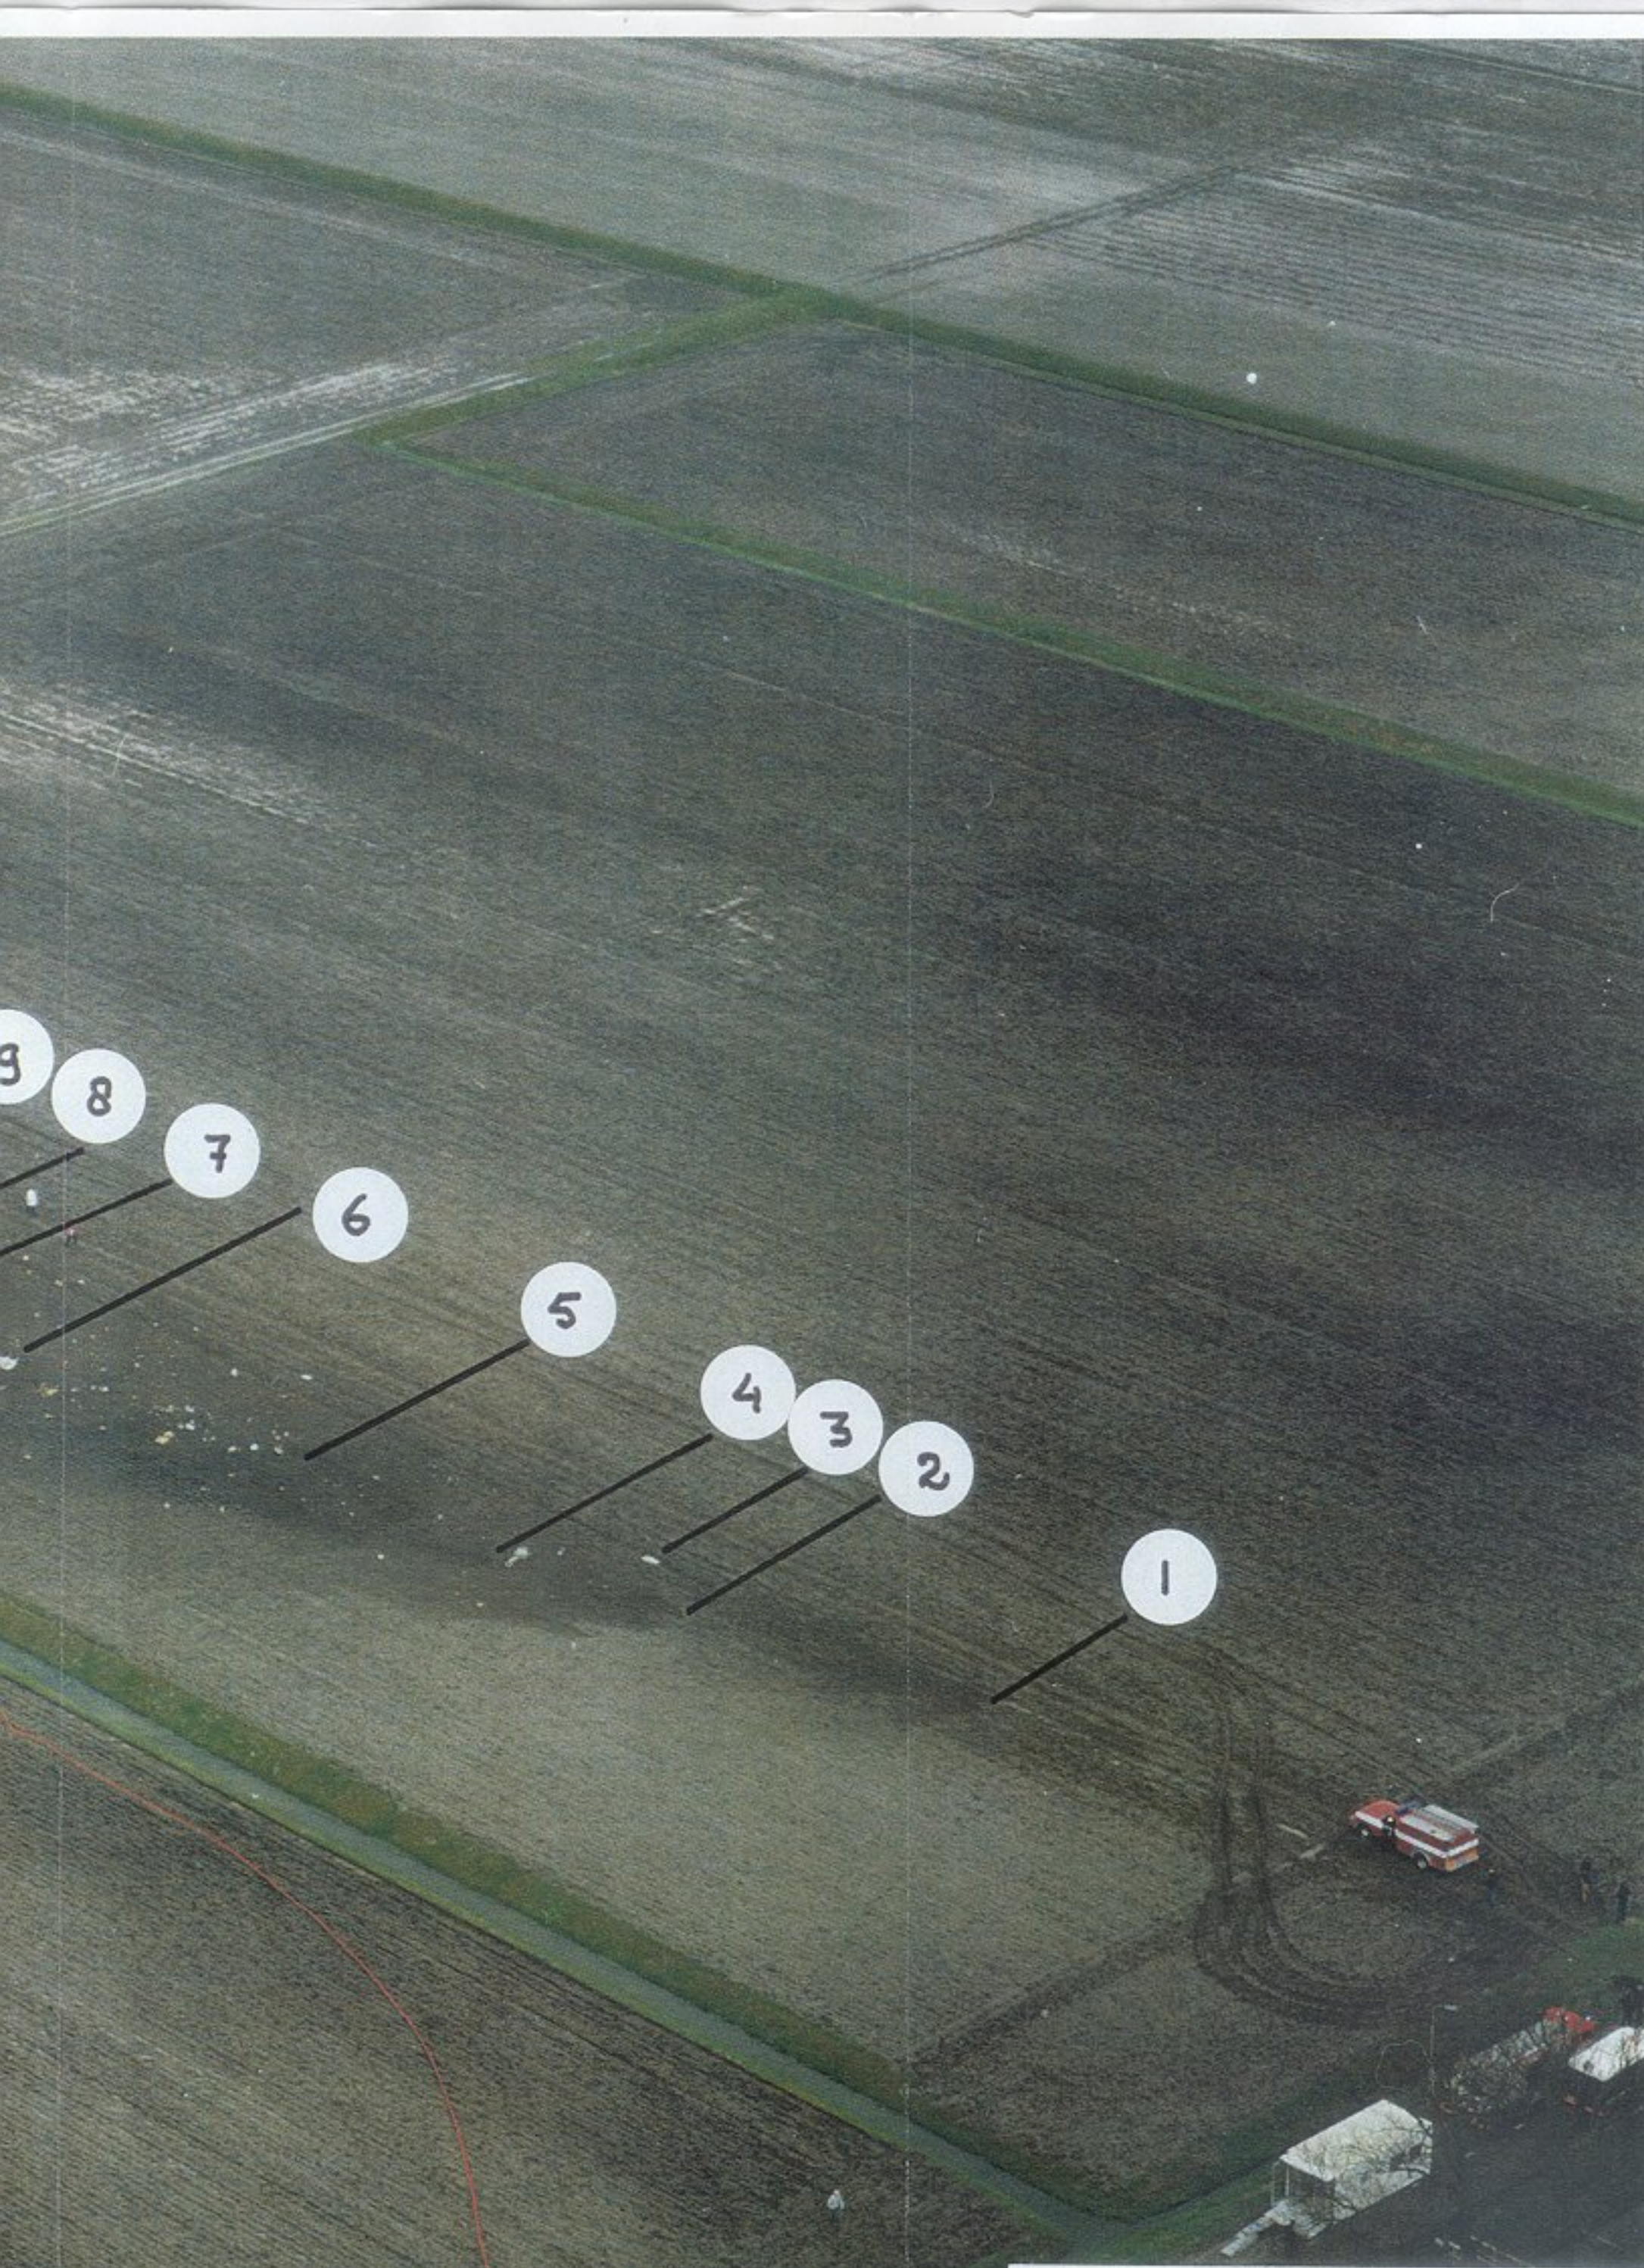
Impact Direction 125°

1. Impact position RH wingtip
2. Impact position inner panel of outer wing
Part of engine cowling
3. Part of RH wingtip
4. Impact position RH engine
parts of propblades
5. Impact position RH side of cockpit and cabin
Pitottube, parts of cockpit, parts of front
exit, parts of cabin wall
6. Inner flap
7. Engine exhaust duct
8. Exhaust pipe, outer wing panel
9. Main gear door
10. RH engine
11. LH stabilizer and elevator
12. Main wreckage
13. Inner wing stub with RH landing gear and
engine mounting
14. Outer flap
15. Inner panel of outer wing
16. RH aileron
