REPORT OF THE CIVIL AERONAUTICS BOARD

Of the investigation of an accident involving civil aircraft of the United States NC 28394 which occurred near Atlanta, Georgia, on February 26, 1941.

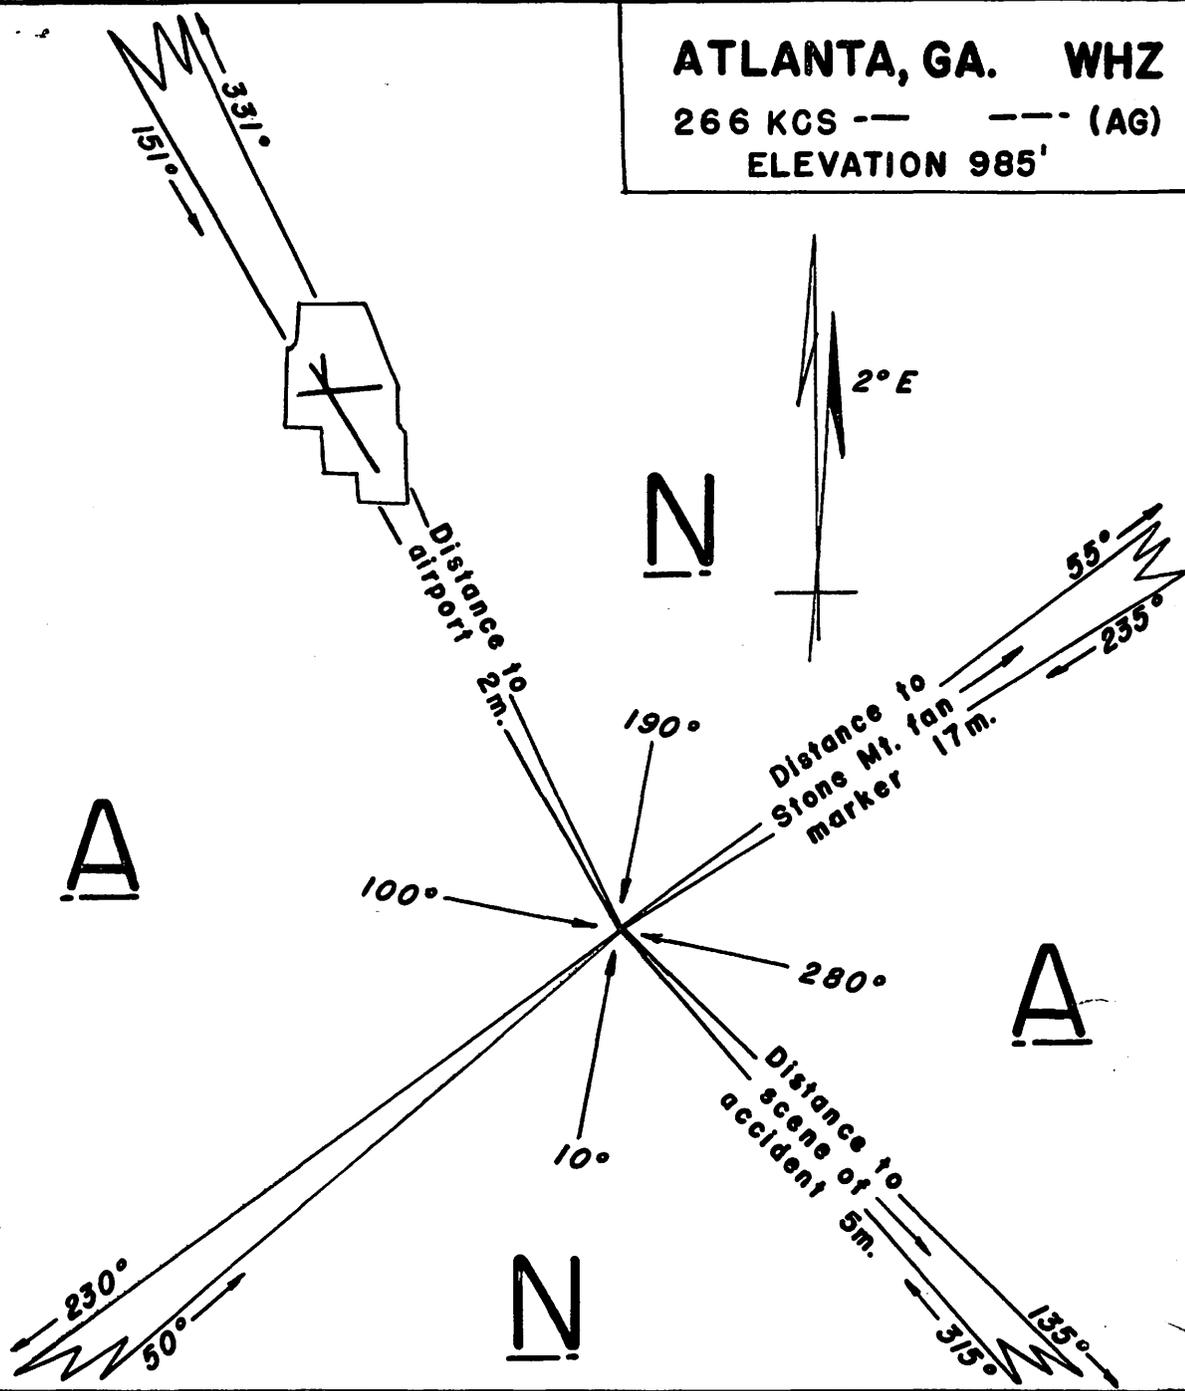
ATLANTA, GA. WHZ

266 KCS — — — (AG)
ELEVATION 985'

PROCEDURE FOR LANDING DOWN THROUGH

Initial Approach Alt. (S.L.)	Radio Fix	Final Approach Leg	Course To Sta. (Mag.)	Altitude Cross Sta. Above Field	To Airport		Authorized Minimums			
					Course (Mag.)	Distance (Miles)	Altitude Day	Altitude Night	Visibility Day	Visibility Night
NE 1800'	*	SE	315°	500 Ft.	329°	2.0	300	300	1	1
SE 1500'	**	Same as above								
SW 2500'	UG	" " "								
N 3000'	CB	" " "
