REPORT

Court investigation of the accident
to the Tudor IV. Aircraft "Star Tiger"
G-AHNP on the 30th January, 1948,
held under the Air Navigation
(Investigation of Accidents)
Regulations, 1922

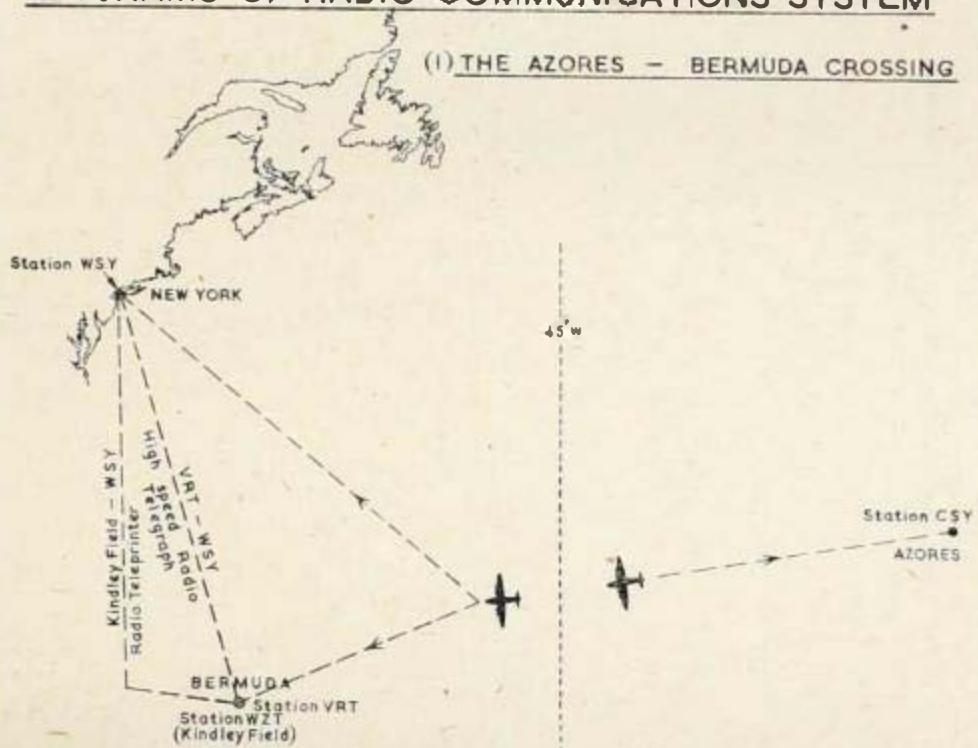
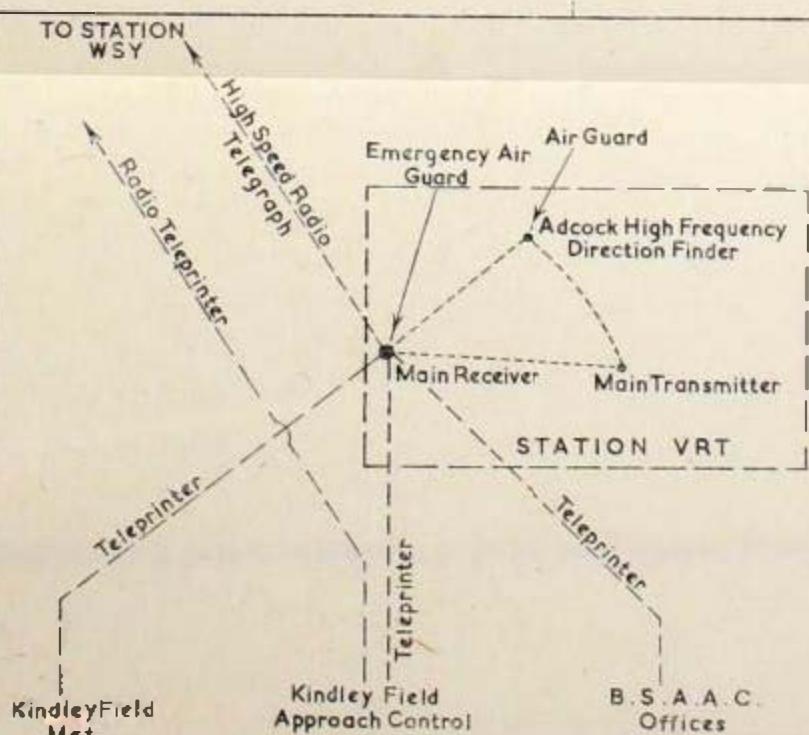
DIAGRAMS OF RADIO COMMUNICATIONS SYSTEM

(2) LOCAL ARRANGEMENTS AT BERMUDA
