PRELIMINARY REPORT

HCL 49/01 Accident	
Aircraft Type: Dassault Falcon 20	Aircraft Registration: D-CBNA
Engine(s): 2 CF 700-2D2	Type of Flight: Charter, IFR
Crew: 2- fatal injuries	Passengers: 1- fatal injuries
Place: App. 4.5 NM SW of Narsarsuaq (BGBW)	Date and Time: 05.08.2001 app. 0445 UTC

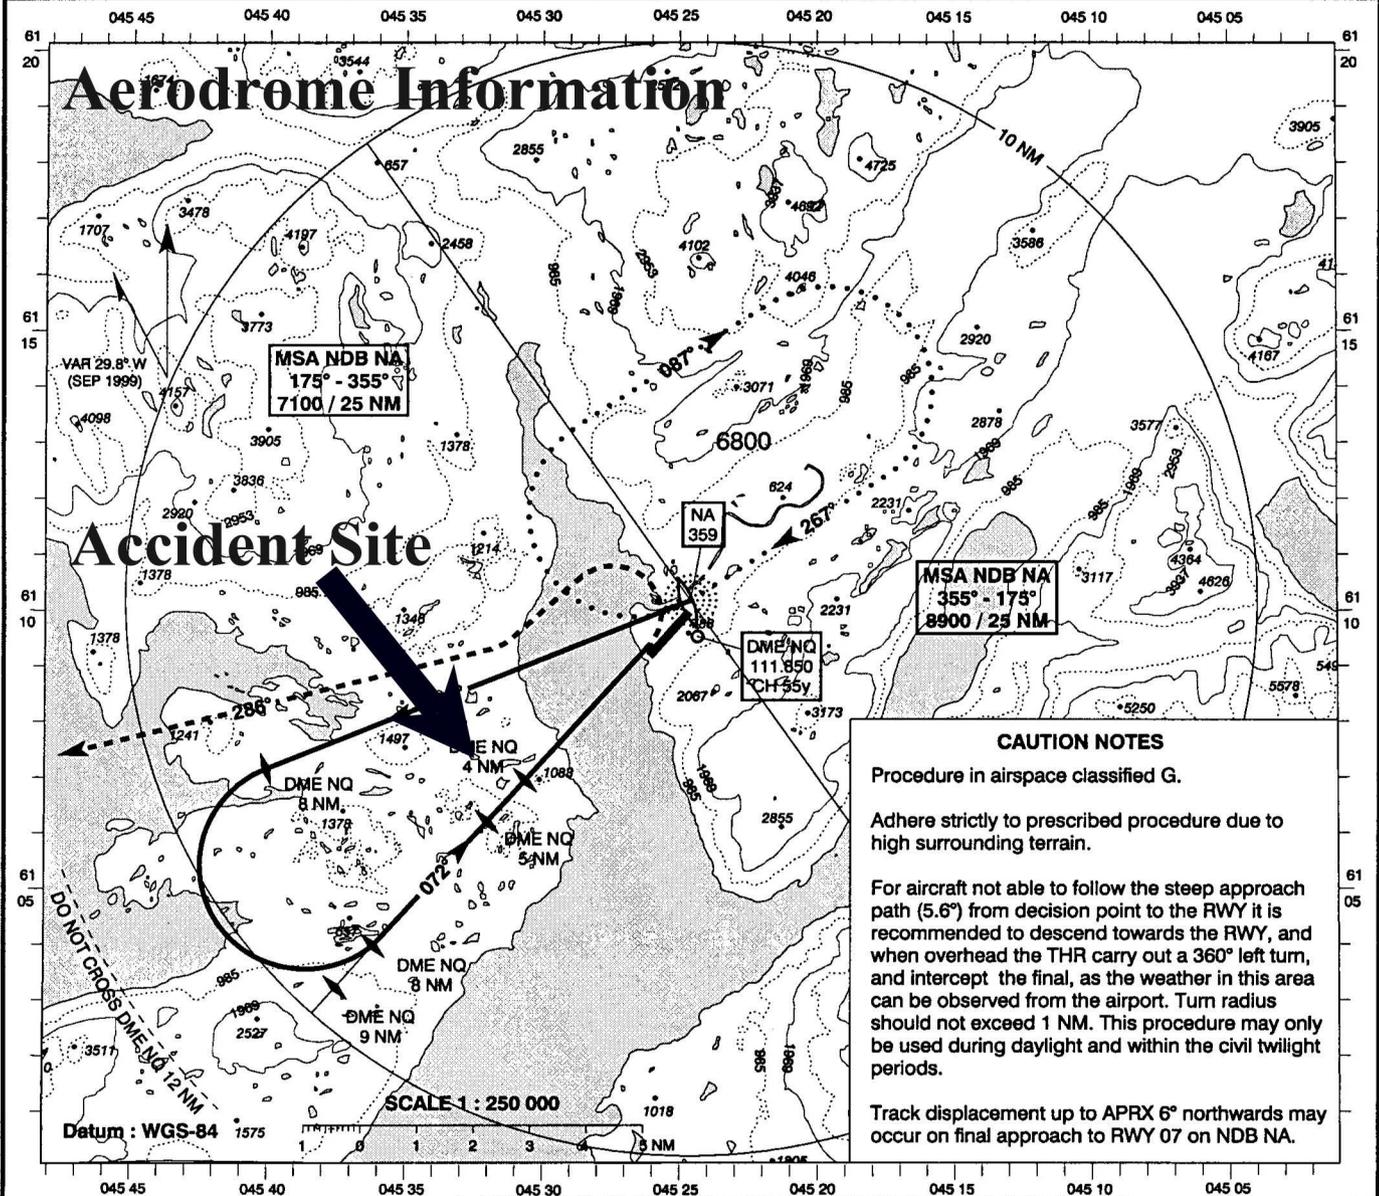
**AD 2 - BGBW
NDB + DME 07 - 1
Narsarsuaq**

**INSTRUMENT
APPROACH
CHART - ICAO**

CAUTION NOTES

Procedure in airspace classified G.

Adhere strictly to prescribed procedure due to high surrounding terrain.

For aircraft not able to follow the steep approach path (5.6°) from decision point to the RWY it is recommended to descend towards the RWY, and when overhead the THR carry out a 360° left turn, and intercept the final, as the weather in this area can be observed from the airport. Turn radius should not exceed 1 NM. This procedure may only be used during daylight and within the civil twilight periods.

Track displacement up to APRX 6° northwards may occur on final approach to RWY 07 on NDB NA.

The wreckage was located at 0810 hrs at app. 700 feet AGL on a position 4.5 NM SW of the airport on a mountainside and app. 0.6 NM W of the inbound course to runway 07.

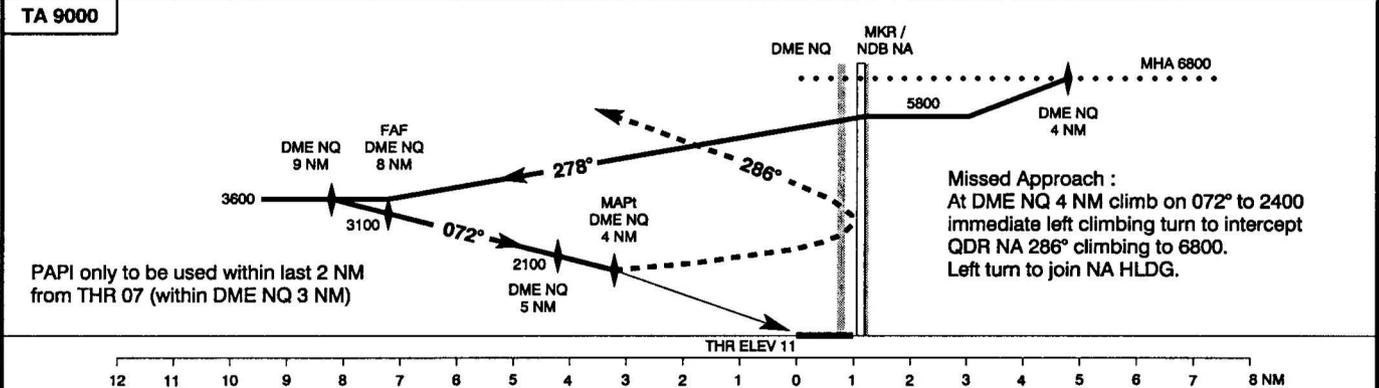
Missed Approach :
At DME NQ 4 NM climb on 072° to 2400 immediate left climbing turn to intercept QDR NA 286° climbing to 6800. Left turn to join NA HLDG.

OCA (H)	A	B	C	MNM missed APCH climb gradient	SPECIAL CONDITIONS					
Straight in	1800 (1790)	1800 (1790)	1800 (1790)	4 %	MAX HLDG and APCH speed 220 KT IAS. MAX missed APCH turning speed 160 KT IAS. Circling N of RWY only. If visual contact is lost during visual circling: Intercept and follow QDR NA 286° as soon as possible climbing to 6800, then turn left and join NA HLDG.					
Straight in	1500 (1490)	1500 (1490)		6 %						
Circling	1800 (1790)	2400 (2390)	3500 (3490)							
DME NQ	NM	1	2	3	4	5	6	7	8	9
DIST to THR	NM	0	1	2	3	4	5	6	7	8
ALT	FT	60	600	1200	1800	2100	2430	2760	3100	3600
