FINAL REPORT

AIRCRAFT ACCIDENT INVESTIGATION REPORT M/s JAHANGIR SIDDIQUI AIR FLIGHT – 201, BEEHCRAFT 1900C-1 REG # AP-BJD CRASHED SHORTLY AFTER TAKE OFF FROM JIAP, KARACHI ON 05TH NOVEMBER, 2010

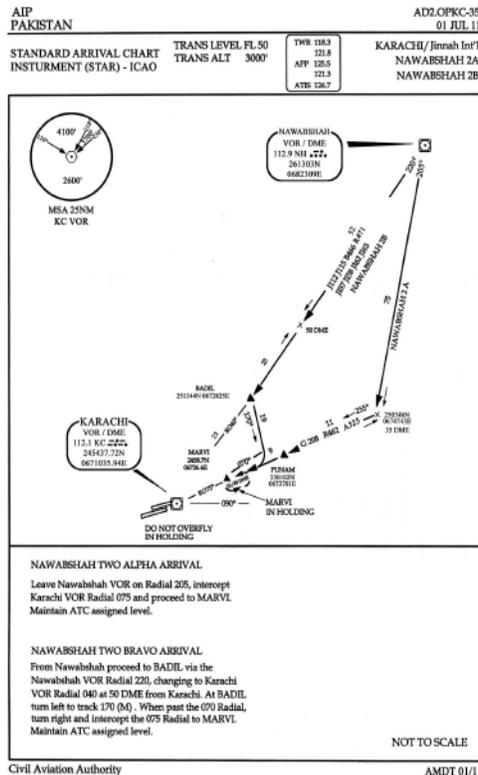
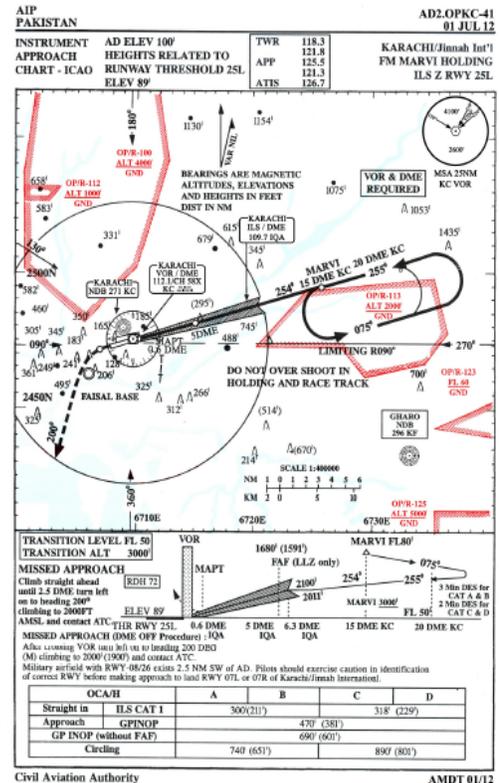
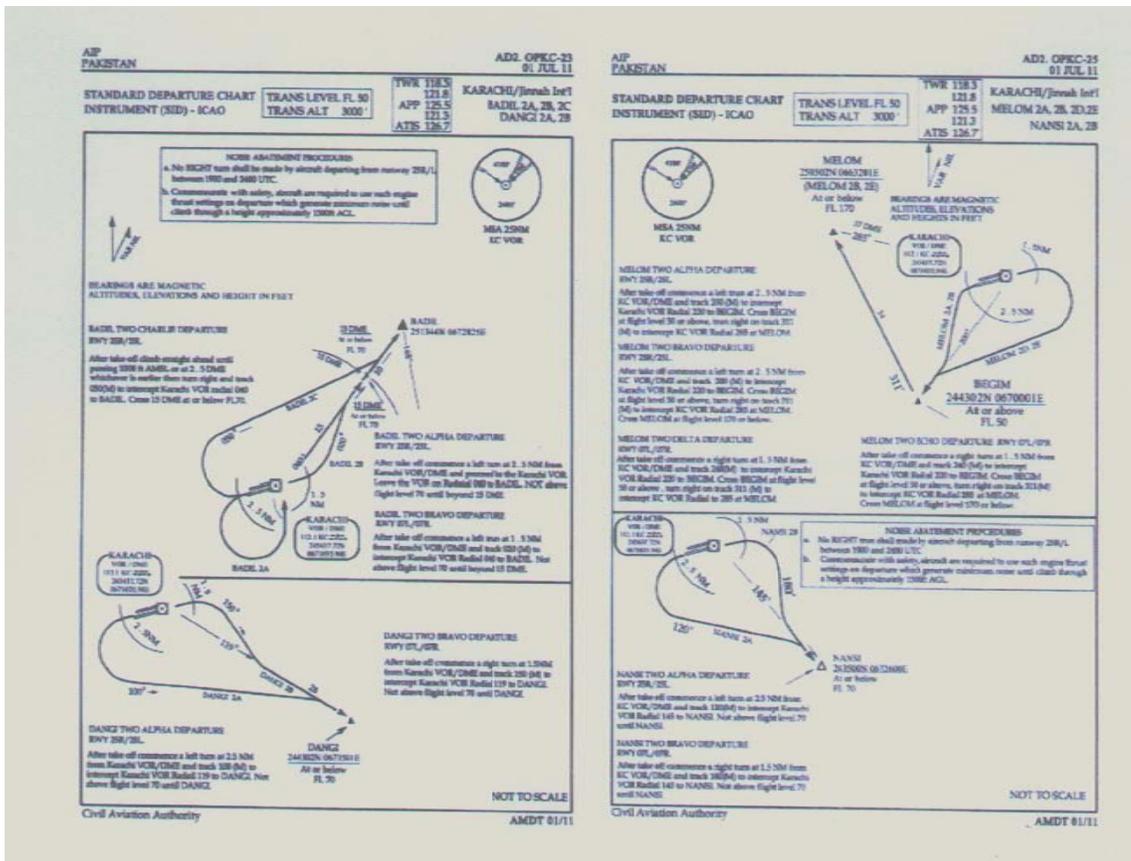
1.14.1 The JIAP Karachi standard arrival chart along with ILS approach runway 25L are appended below:
